# Property Inspection Report

1234 Sample Way, Haymarket, VA 20169  
Inspection prepared for: Chris Sample  
Real Estate Agent: -

Date of Inspection: 4/2/2026 Time: 2:00 PM  
Age of Home: 2004 Size: 2736  
Order ID: 1443

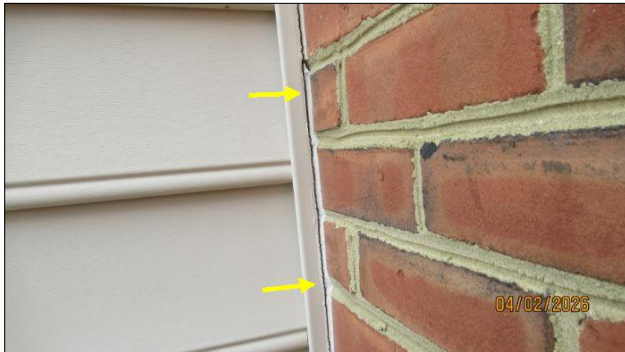
- Caulk is needed at siding intersections with windows, doors, trim, and brick. This is important to prevent rain and pest entry. Use an outdoor rated silicone caulk.

caulk needed

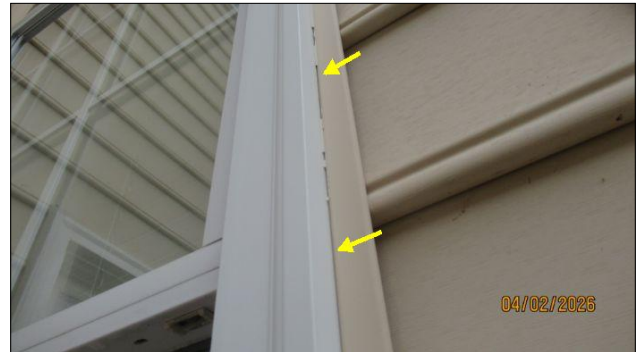
caulk needed

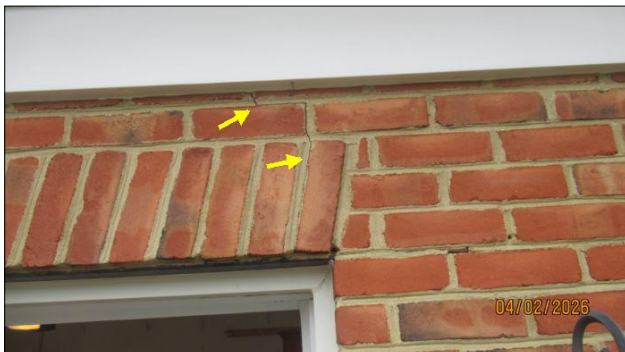
- There are one or more areas of the brick veneer that need brick repointing as evidenced by cracking and/or deteriorated mortar. This should be repaired in order to control water intrusion. A licensed brick mason is advised for repair.

cracking mortar

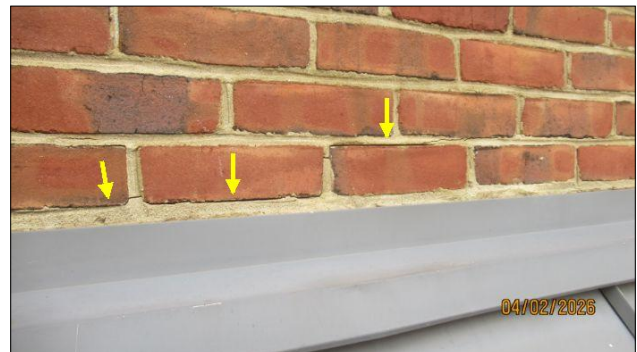
cracking mortar

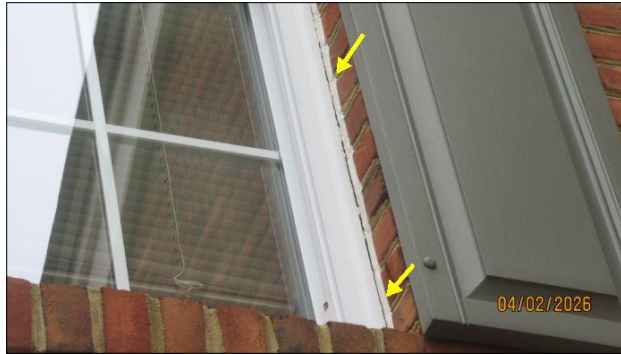
- The windows were viewed under overcast conditions which can obscure the actual conditions of all glass in the home from seeing failed double glass seals. Failed windows may exist that can escape our attention today. Review all the windows under better clear sky conditions as available. We are not responsible if failed windows exist that go undetected due to weather circumstances.
- One or more windows need caulking in the brick frame to ensure water tightness, this is important.

caulk needed

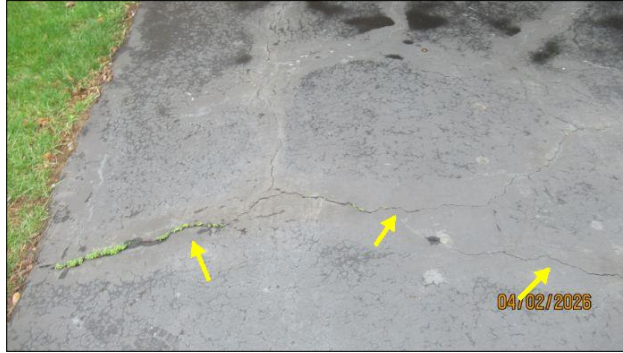
- Driveway is in average condition due to age and normal wear resulting in cracks, settlement, etc... Maintenance is needed.

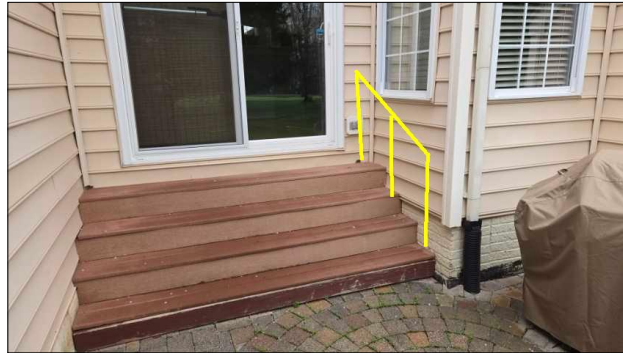
- No hand rails present at rear steps. Heights of stairs above grade of more than 30" require a guard rail. Recommend railings be installed that conform to current standards--Safety Concern.

add railing

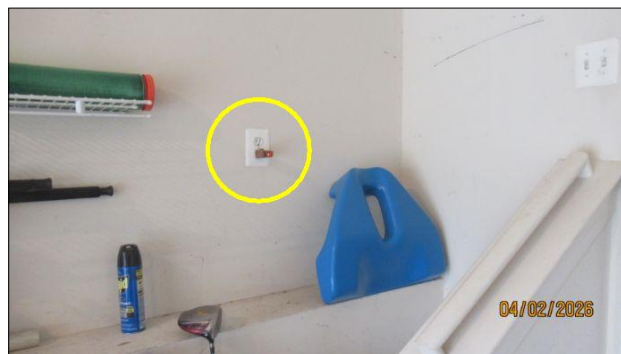
- At least one outlet is Not **GFCI** protected. Considering the age of the home, all of the garage electrical outlets, except dedicated circuits, should be protected using Ground Fault Circuit Interrupters. Repair is needed for safety. Consult a licensed electrician.

outlet not GFCI protected

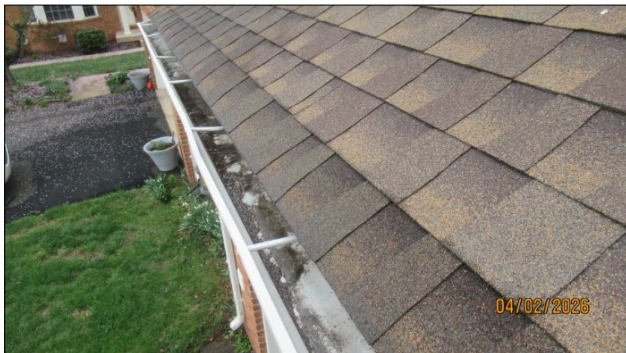
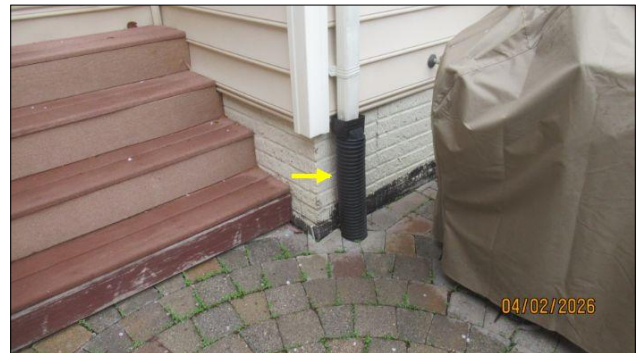
- One or more of the downspouts go into an underground system. It is unknown if they are functional or where they daylight.

unknown daylight

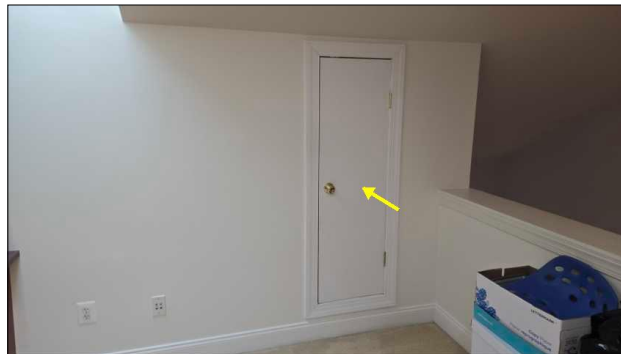
- Loft attic wall access door panel is a hollow core door and should be a solid core for insulation purposes. Upgrading is advised.

hollow core door

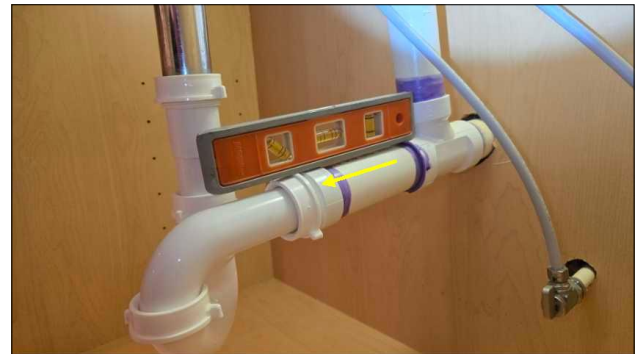
- The bar area refrigerator was not tested as it was unplugged at the inspection. It is unknown if the appliance conveys with the home.
- The sink drain piping slopes toward the front of the cabinet slightly. The sink did drain when tested, however, there were some gurgling sounds when draining indicating some possible venting issues. Repair is advised if this sink is to be used regularly.

drain slopes forward

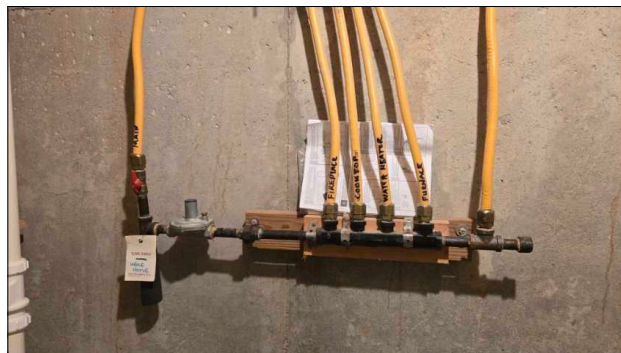
- The gas supply materials are **CSST** (Corrugated Stainless Steel Tubing) with a manifold distribution.
- There is **NO** Visible bonding of the CSST gas piping material to the electrical system. Manufacturers believe that this product is safer if properly bonded and grounded as required by the manufacturer's installation instructions. Proper bonding and grounding of the product can only be determined by a licensed electrical contractor. Check with your local master electrician, or county inspection department and upgrade as needed for safety reasons.

No visible bonding

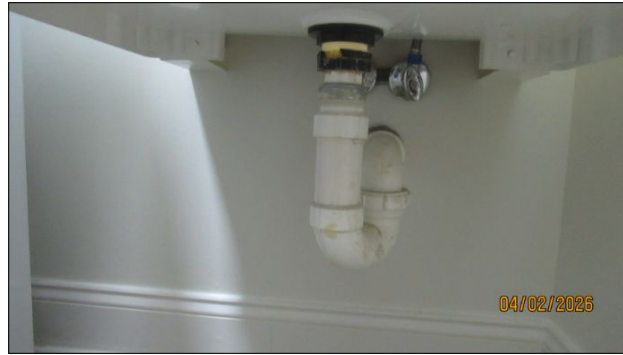
- There is evidence of a leak in the drain piping under the sink. Repair is advised.

drain leak

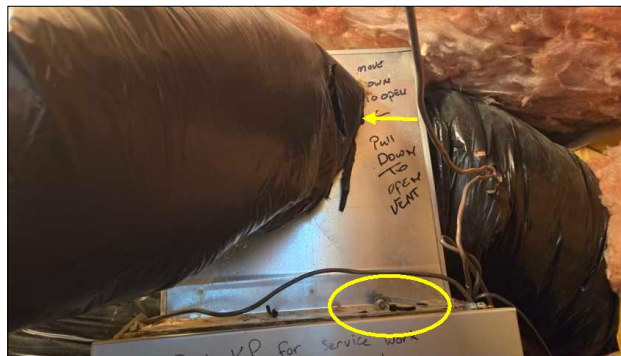
- Unless otherwise noted in the report each habitable room on outside walls has a heat source.
- Air ducts, conditions and airflow appear acceptable in those areas that are accessible.
- Dampers are installed inside the ducting for balancing airflow during the different seasons, however, at least one damper handle is missing/broken. As a result, it could not be determined what position this damper is in (open or closed). This could limit or completely close off airflow to one or more areas of the home. I recommend evaluation of the damper by a licensed HVAC contractor and install the appropriate damper handle in order to determine damper position. Located at the upper level heat pump.

Broken damper handle

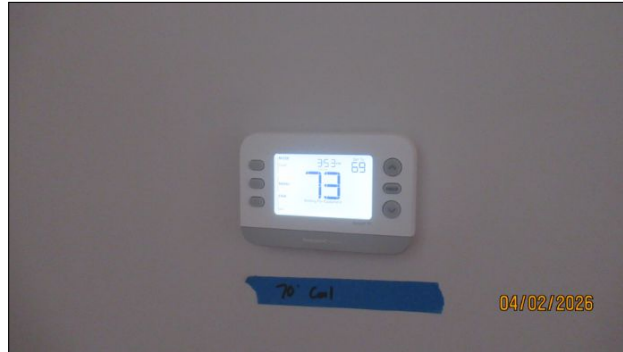
- A combination of thermostats are installed due to the multi-zone setup:
- The thermostat is located at the main level.
- The thermostat is located in the master bedroom.
- The main floor thermostat is loose to the wall. Secure as needed to prevent connections from coming loose.

main level t-stat loose

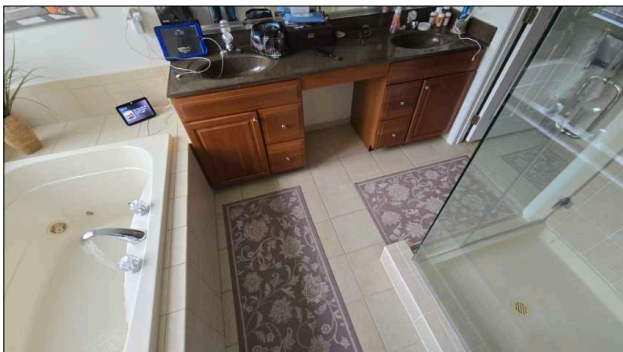
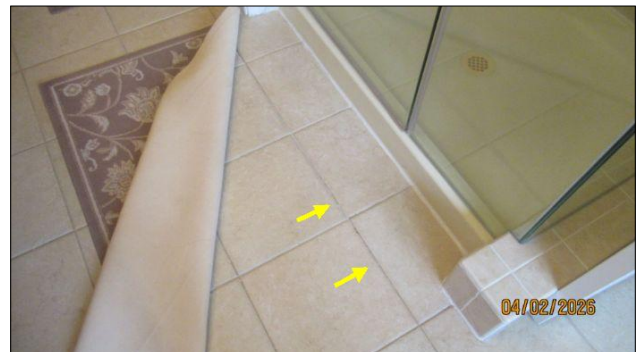
- The floor covering is ceramic or similar type tile.
- There is missing/deteriorated grout in places that needs repair: in front of shower. Repair as needed to prevent moisture from getting to the subfloor.

deteriorated grout

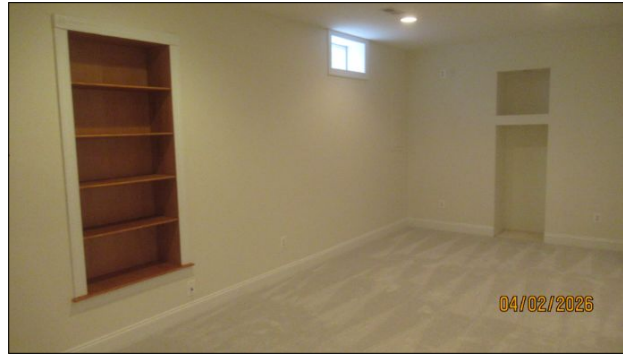
Observations:  
• The lower level windows appear to be in satisfactory condition.  
• The windows as installed are not egress accessible as defined in current building standards. As a result of the lack of egress, the areas should not be considered as a sleeping area for safety reasons.  
• The installed windows are below grade and installed in wells that should minimize the probability of water leakage. Some have drainage systems installed in the window well, some do not.

no egress

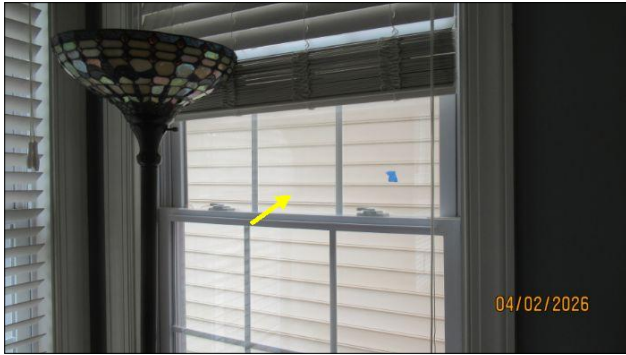
seal failure - family room

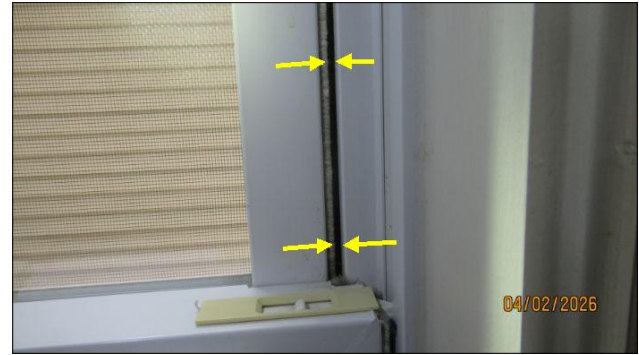
- Gaps were noted in the window sashes at the jambs at several locations. This may allow cold air infiltration during the winter months. Evaluation is advised to determine if the jambs can be adjusted to seal the gaps.

gaps at window jambs

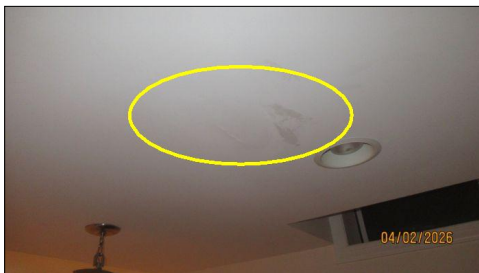
- There is an active moisture leak observed that needs attention. Located in the basement bar ceiling. The presence of recent moisture was verified with a moisture meter and thermal camera. A qualified contractor is needed for evaluation and repair.

basement bar ceiling leak

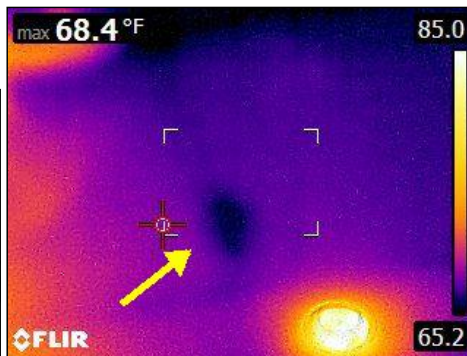
basement ceiling moisture - thermal image

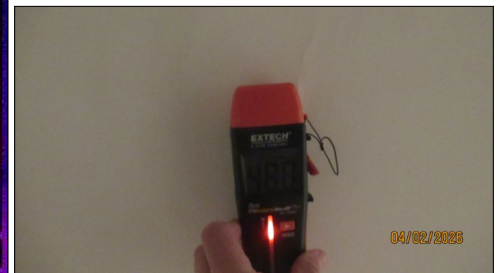
moisture meter

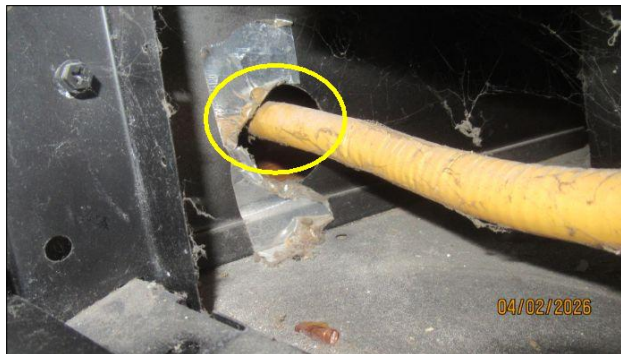
- The observed flexible gas line is not protected where it enters the metal firebox. These need a sleeve around the pipe to prevent damage to the gas line from the sharp metal edges of the firebox. It is important to have a certified gas professional evaluate the installations and make corrections as needed.

no sleeve for gas line
