# Property Inspection Report

12345 First Timers Way, Anytown, VA 20155  
Inspection prepared for: John Q Sample  
Real Estate Agent: Agent Smith - Local Realtor - Mytown

Date of Inspection: 11/4/2017 Time: 0900  
Age of Home: 30 Size: 2200

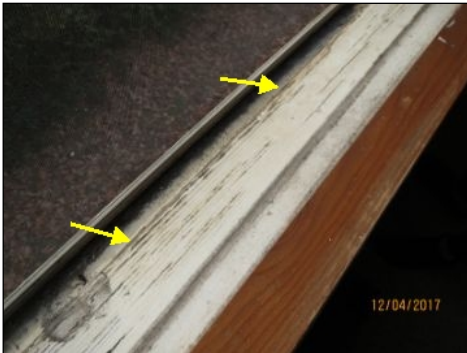
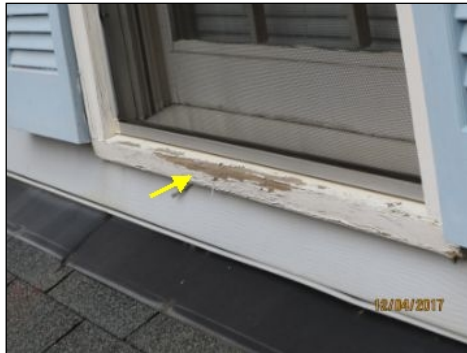
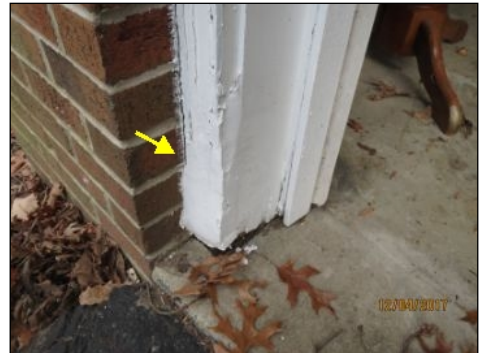
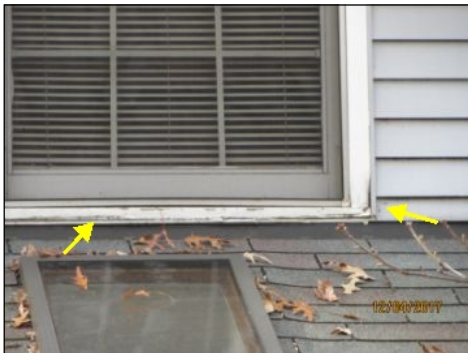
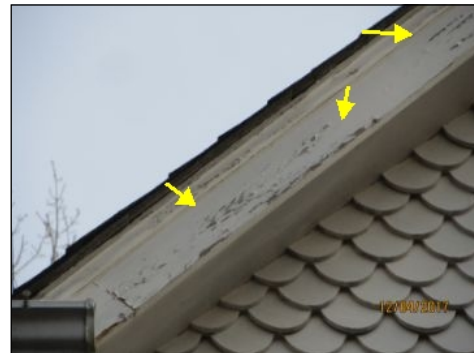
- Cracking/Peeling paint is observed on the exterior trim as viewed from the ground. Exterior wood/painted surfaces need thorough evaluation, surface preparation, paint, and caulk. A full evaluation of all exterior trim is advised.

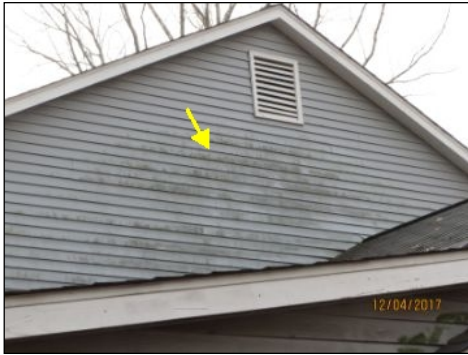
- The siding needs to be cleaned as a part of regular maintenance.
- There are missing/damaged vent cover(s) to external exhaust ducting at the siding. Repair as needed to prevent nesting or water entry.

cleaning needed

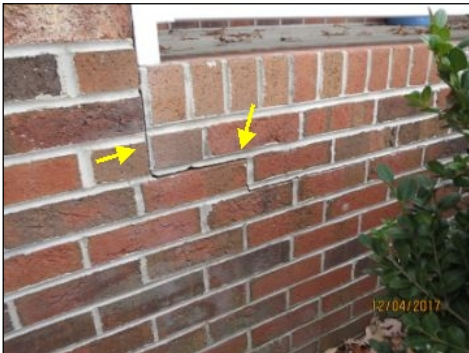
- There are areas that need brick repointing to control water intrusion, looseness, etc.. Monitor for future movement.
- Expanding lintels are observed in places. This is caused by the steel rusting and expanding due to moisture. Over time this can create serious gaps or cracking of masonry surfaces. Consult a licensed brick mason for evaluation and repair.

repointing needed

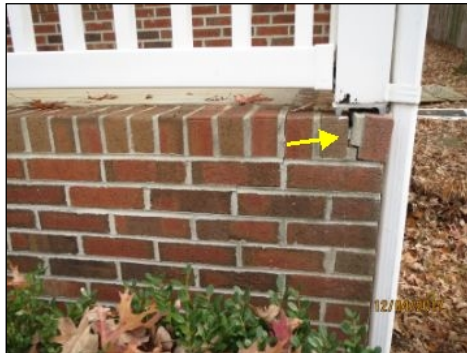
loose brick

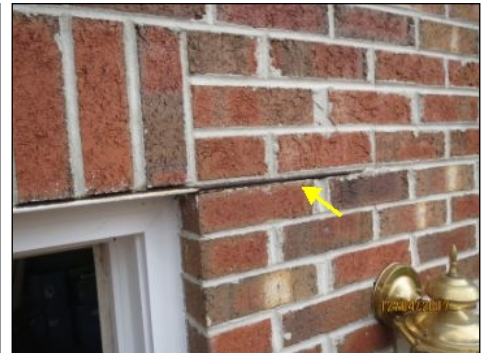
expanded lintel

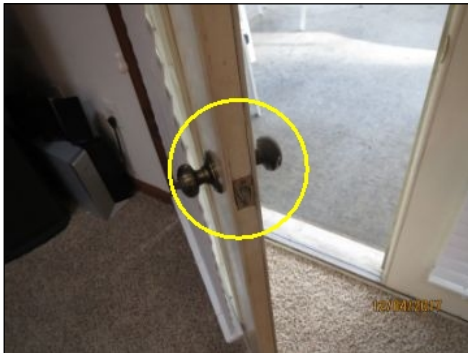
- The door hardware, locks are inoperative, loose, broken, missing, poor fitting etc. needing repairs. Located at rear door.
- The weather stripping needs to be improved, i.e. jamps, sweeps, etc. at the rear door(s).

non-functioning hardware

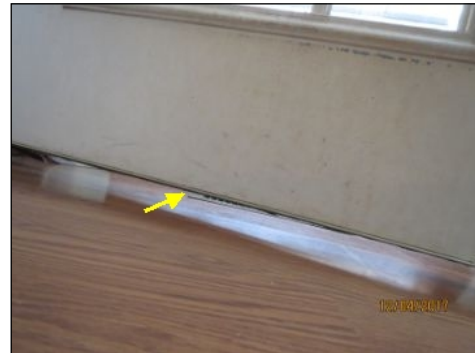
bad weatherstrip

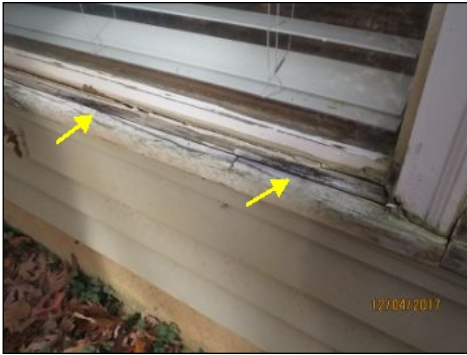
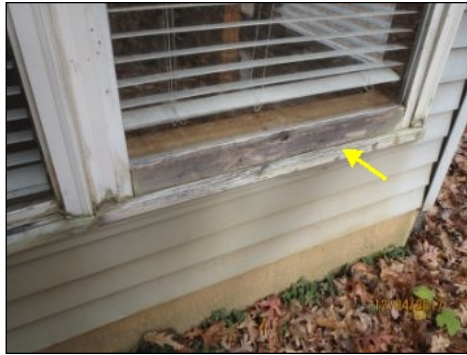
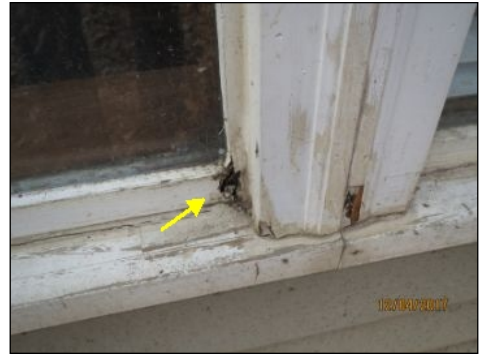
- The windows were viewed under overcast conditions which can obscure the actual conditions of all glass in the home from seeing failed double glass seals. Failed windows may exist that can escape our attention today. Review all the windows under better clear sky conditions as available. We are not responsible if failed windows exist that go undetected due to weather circumstances.
- Windows have cracking/peeling paint in places. Windows need thorough surface preparation, paint, putty, and caulk. Use primer where bare wood is exposed.

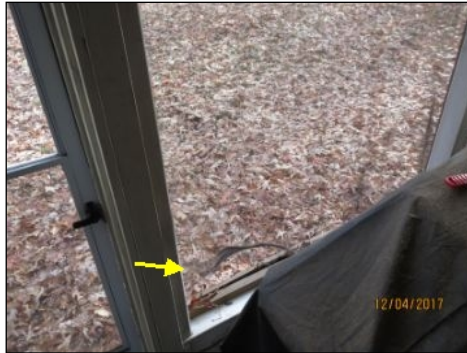
damaged screen

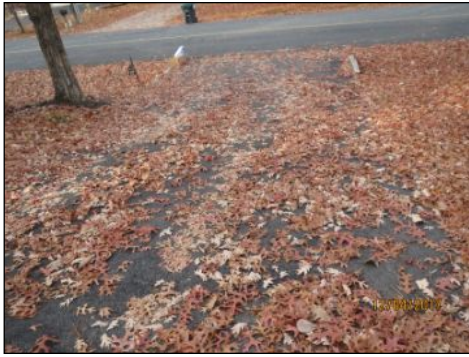
limited visibility

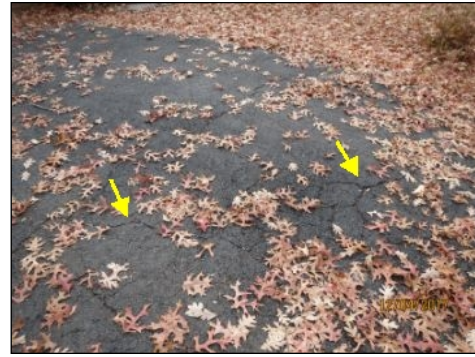
- Inspection Limitations: Full access to driveway not possible due to snow/ice/debris cover preventing visibility.
- Driveway is in average condition due to age and normal wear resulting in cracks, settlement, etc... Maintenance is needed.

minor cracking

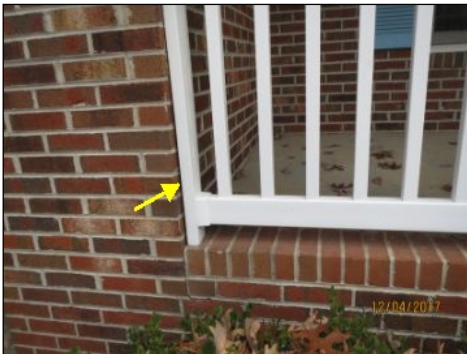
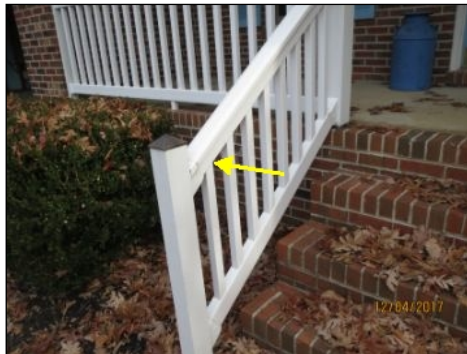
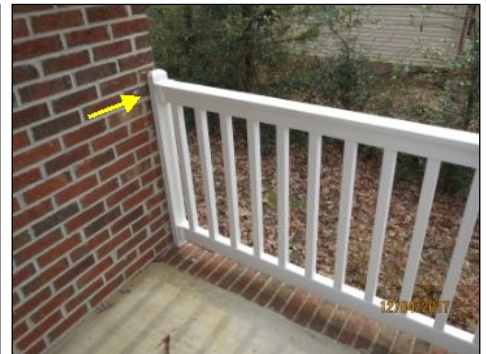
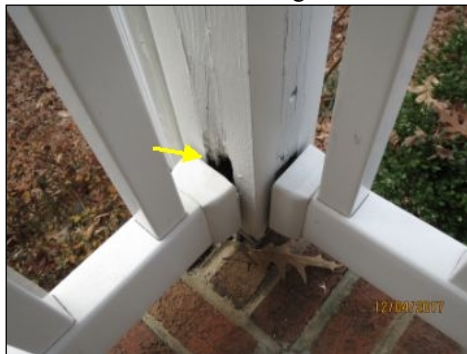
- The exterior railings are loose on the front porch. Repair is needed for safety.

loose railing

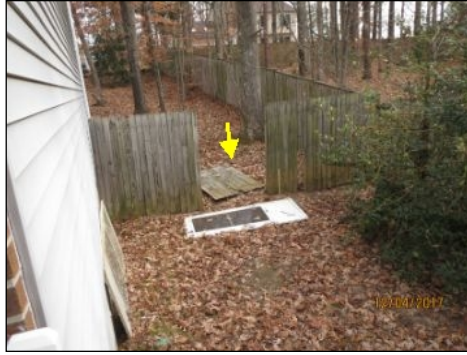
Materials: Type of fencing • chain link • wood • There are Cracked/Missing/Loose fence members needing repairs.

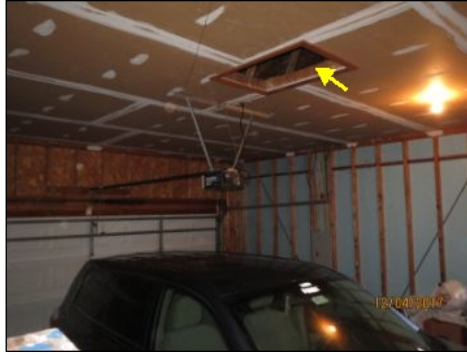
- The attic access hatch needs to be installed to prevent the spread of smoke or fire.

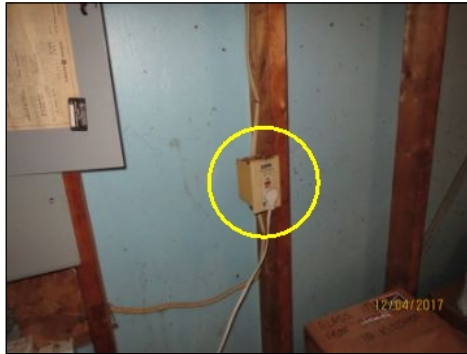
- The Ground Fault Circuit Interrupt (**GFCI**) protected outlet did not break the current flow when tested and needs replacing. This appears to be the master device as the downstream outlets on the exterior of the home and in the bathrooms did not trip when tested. Consult a licensed electrician to replace the bad GFCI receptacle and then verify proper protection at all downstream receptacles.

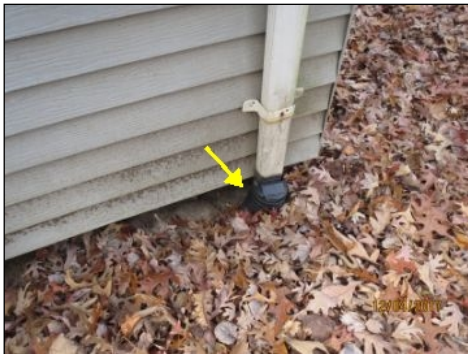
- One or more of the downspouts go into an underground system. It is unknown if they are functional or where they daylight.
- The gutter system on the roof edge has loose, missing or spikes needing renailed. Repair is needed.

unknown daylight

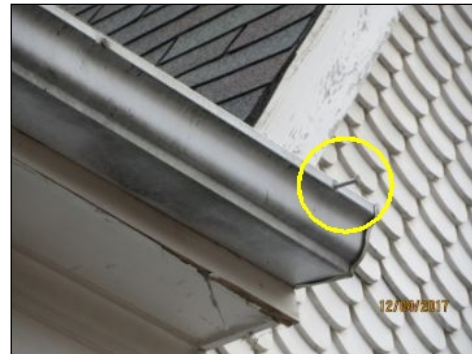
loose gutter spike

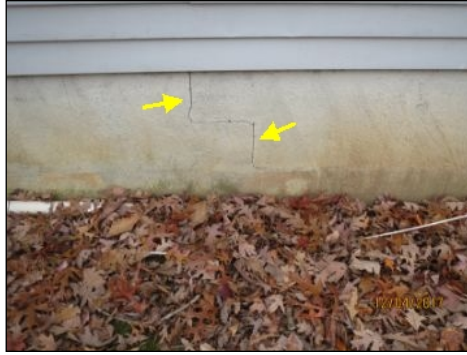
- The exposed portions of the perimeter foundation walls appear to be adequate and are functioning as intended at this time. One minor crack was noted. These are common due to age and type of material. Should the crack grow, further evaluation is advised.

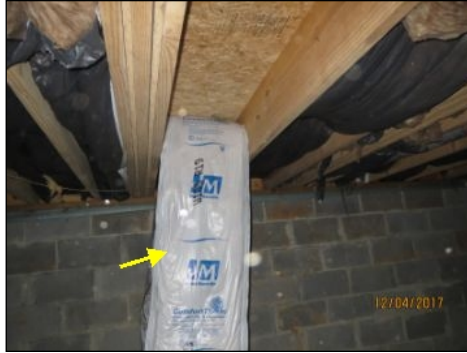
- Fallen insulation is observed in areas of the crawlspace. Re-installation of the insulation is advised to promote proper insulating properties and to control moisture. The repairs are advised utilizing professional technicians familiar with this type of environment.

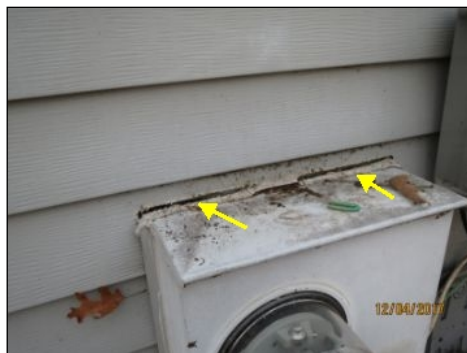
- The meter base needs caulking to prevent unwanted water entry.

caulk needed

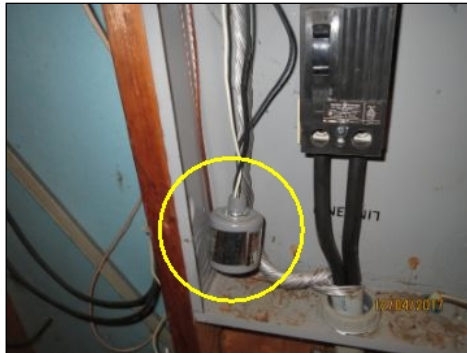
- There is a surge protector mounted inside the panel box. Damage can occur if improperly installed. Typically, the protection should be mounted on the outside of the panel. Consult a licensed electrician to determine if the configuration is allowed and make any repairs as needed.

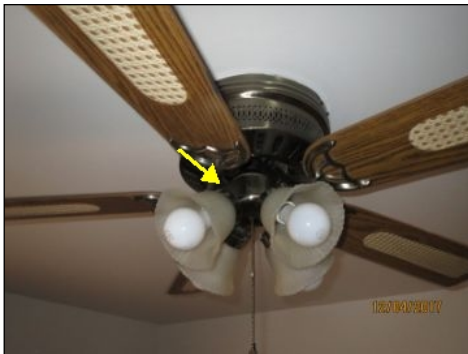
- rear bedroom fan light kit is loose. Master fan junction box cover is loose. Repairs are advised.

loose light kit

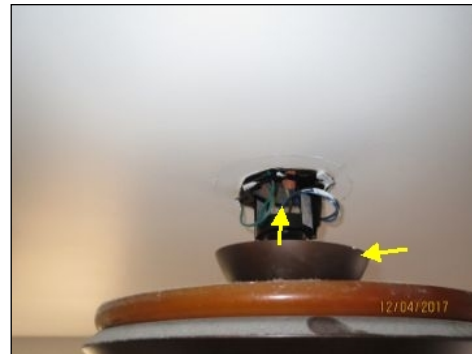
install cover

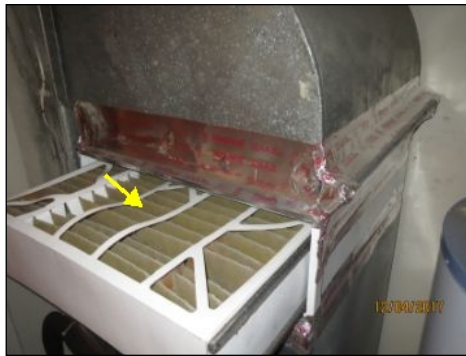
- Filter(s) need cleaning or replacement now. Check filter(s) monthly for maintenance.

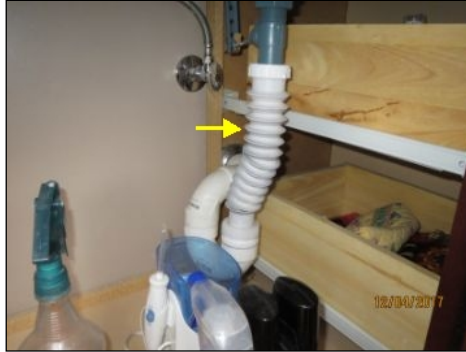
- The installed flexible trap/drain assembly is not an approved material, or it is installed in an unacceptable manner. Rigid or smooth walled pipe is recommended to prevent bacteria or scum from forming in the grooves. Replacement is recommended.

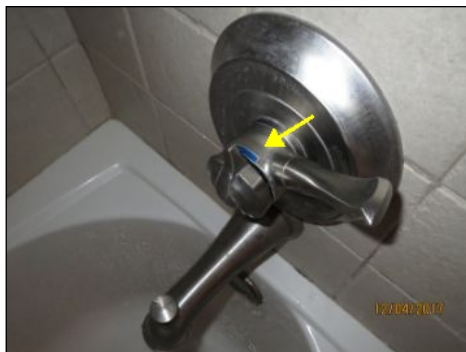
- The Hot and Cold are reversed to the tub faucets. Repair is advised.

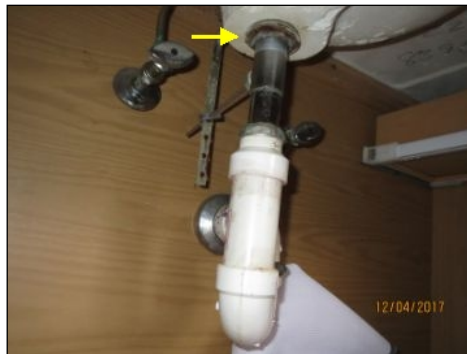
- There is an active leak. Evaluation and repair by a licensed plumber is needed.

active leak

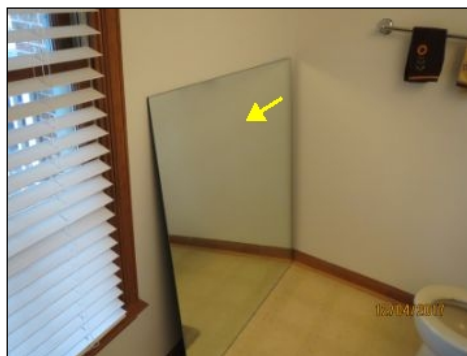
- The vanity mirror needs to be installed.

install mirror

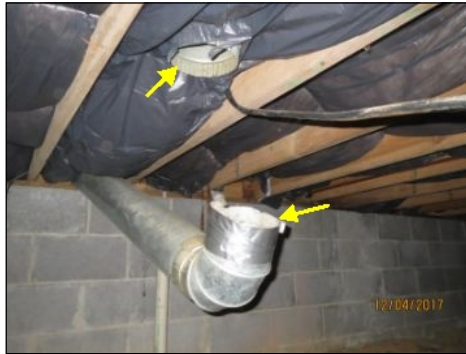
Observations: Vent pipe is disconnected in crawlspace. Repair is needed.

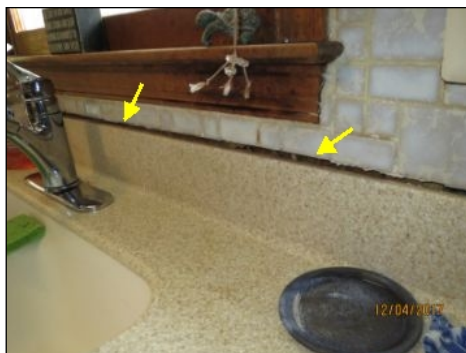
• The caulking to the counter and wall intersection, behind sinks, etc. need to be improved. If left unsealed, water can cause damage and mold conditions.

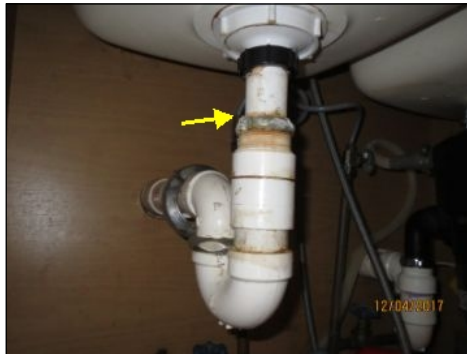
- There was evidence of a leak. Monitor for future repairs. No leaks at the inspection.

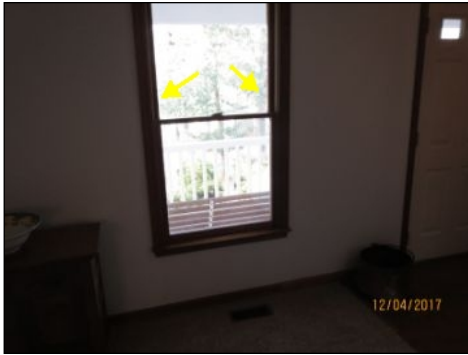
- The spring, cord or slide that holds the window in the up position is nonfunctional. It needs to be repaired or replaced for safety reasons. Located in living room
- There are windows observed in the home with clouded or failed double glazing seals. Others may exist and are difficult to detect due to tinted glass, sun orientation or dirty glass. Recommend all windows are evaluated by a qualified window professional.

bad springs

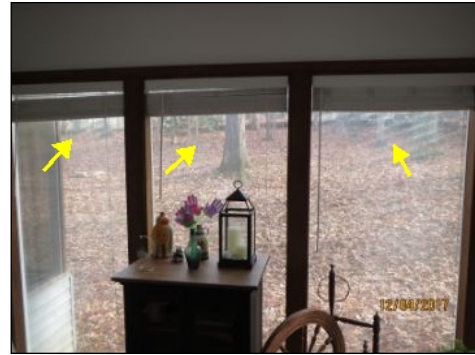
thermal seal failures

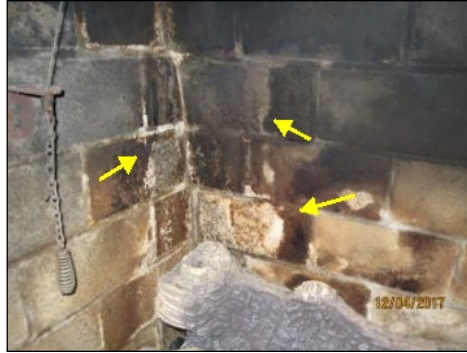
- There are moisture stains in the firebox. The source of the moisture is undetermined. Recommend contacting a certified chimney sweep to determine the source of the moisture and an estimate to correct.

moisture stains
