Diamond Heritage Inspections, LLC.

Home Inspection Report

123 DHI st

Inspected on Sat, Mar 13 2021 at 6:45 AM

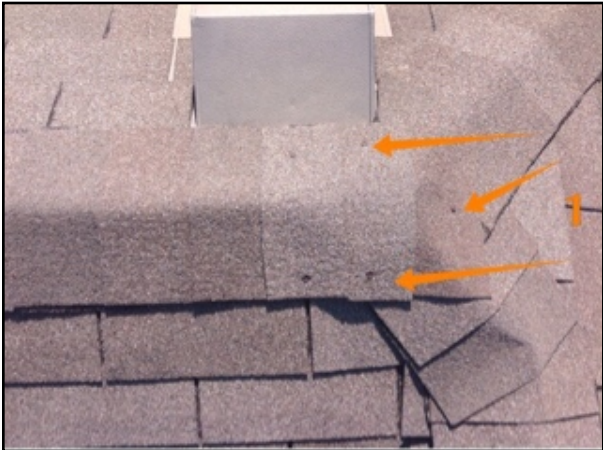
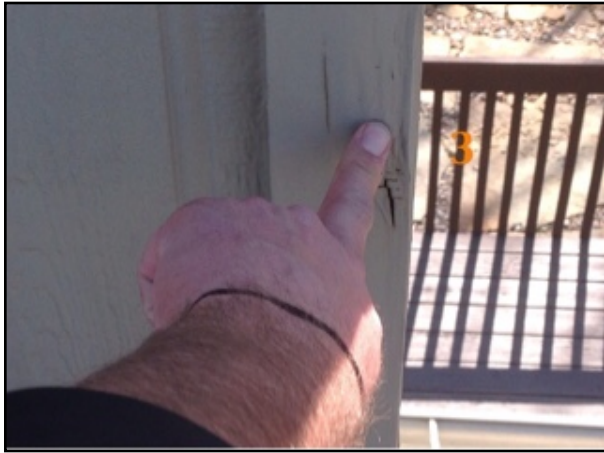
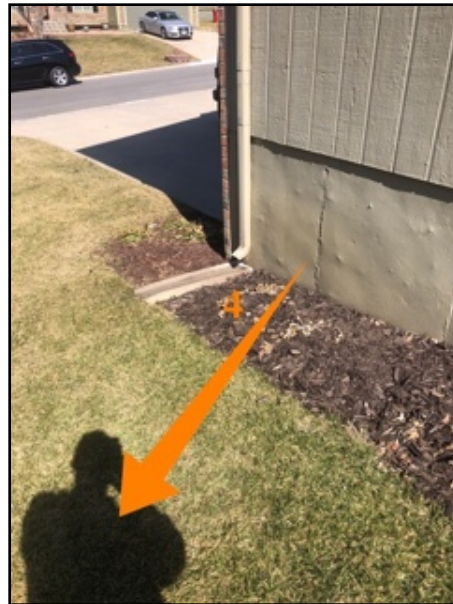
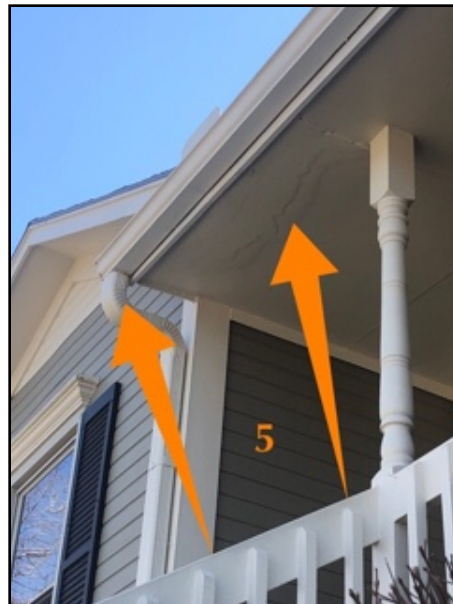
1. Inspector recommends to seal nails at ridge cap, roof vents, skylights and plumbing vents.
2. Inspector recommends to re-seal rain cap at chimney.
3. Inspector notes rotted siding and trim boards around chimney, recommend replacing these areas.
4. Recommend to add downspout extensions to all downspouts that are not part of the drainage system.
5. Inspector notes deterioration to the ceiling at the front porch. This shows potential water backing up in the gutters. Inspector would recommend correcting the guttering and repairing the ceiling.
6. Inspector notes rotted fascia board at the north west corner, recommend repair or replace.

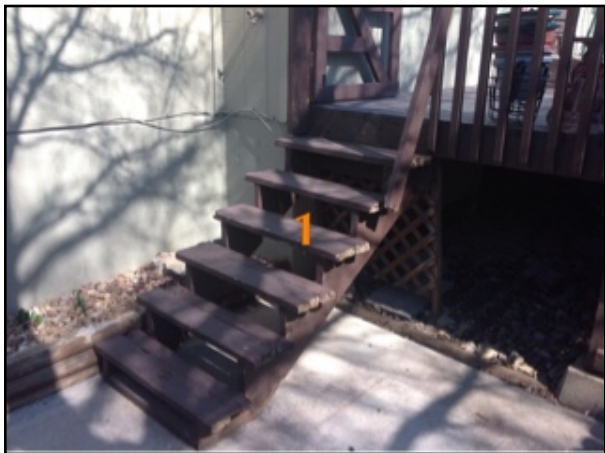
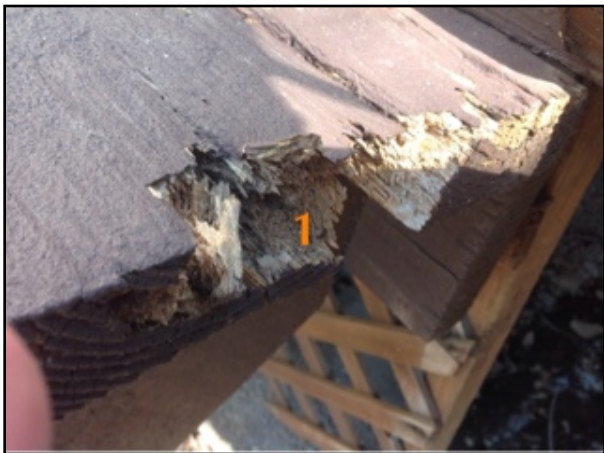
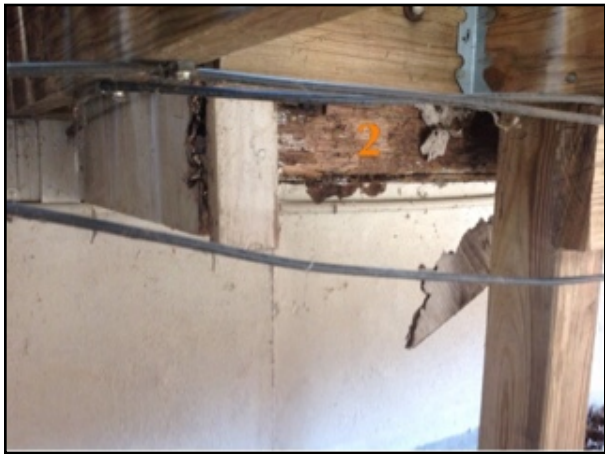
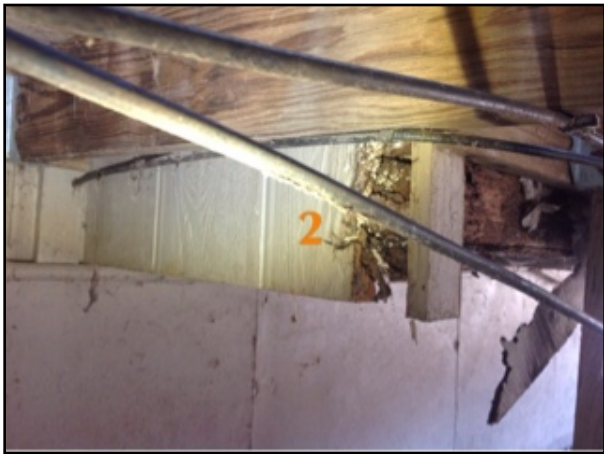
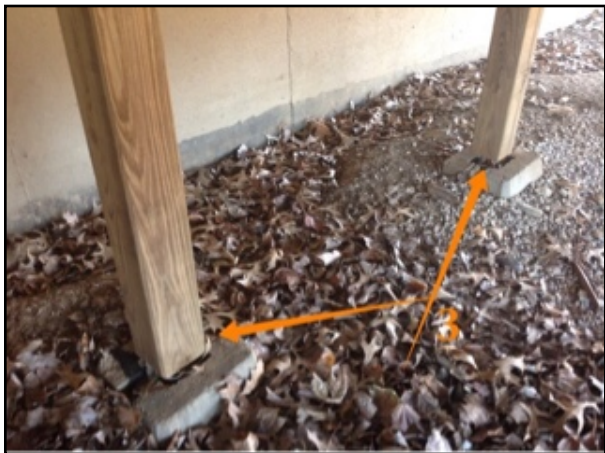
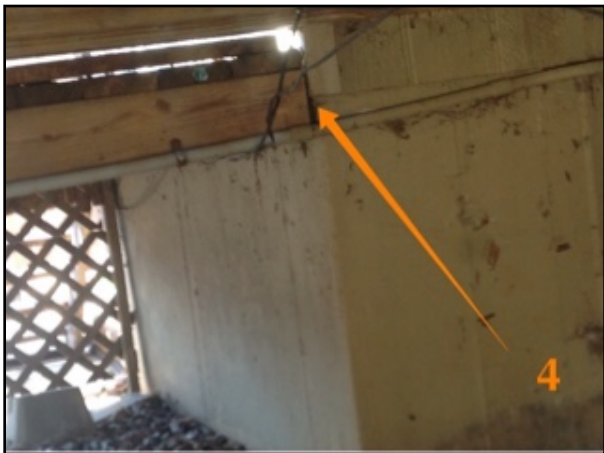
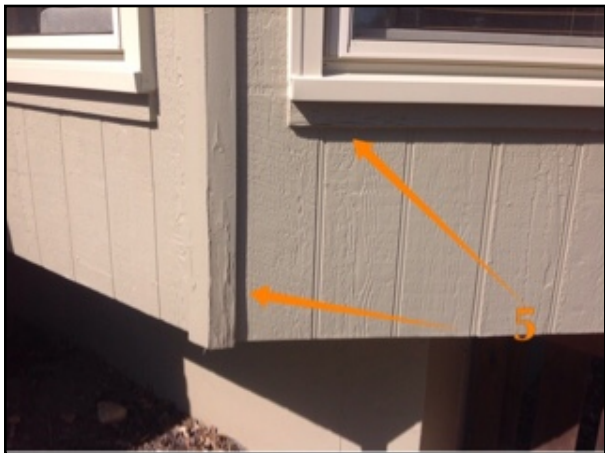
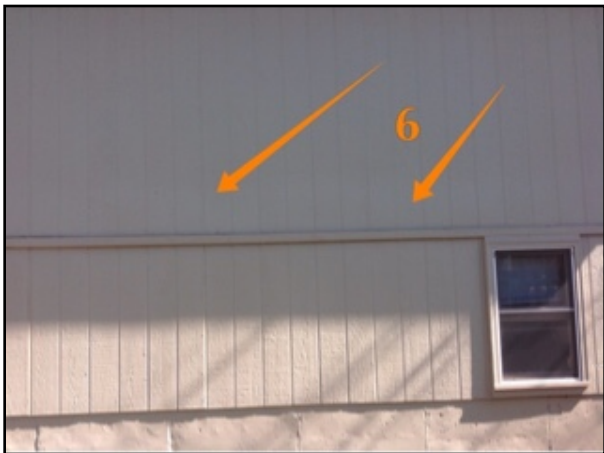
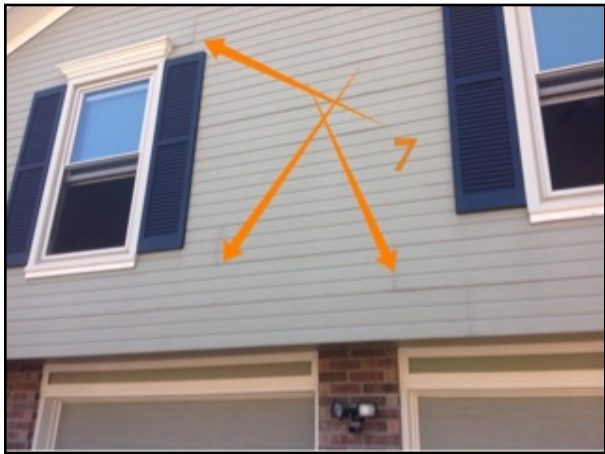
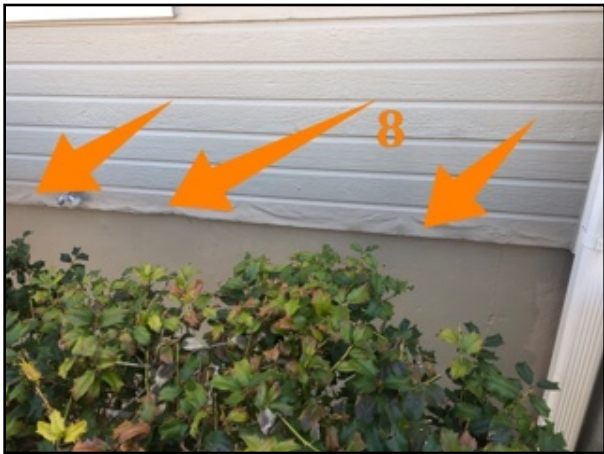
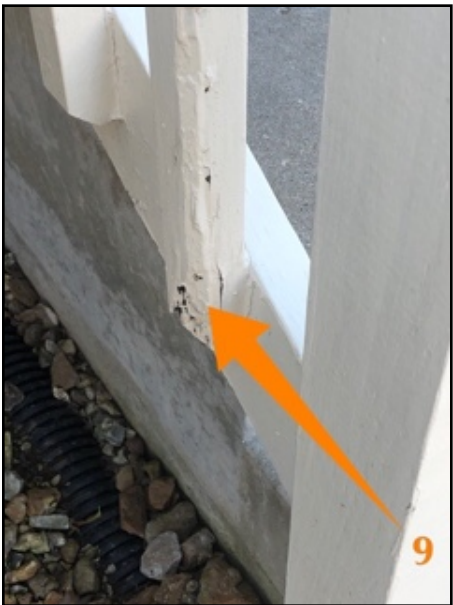
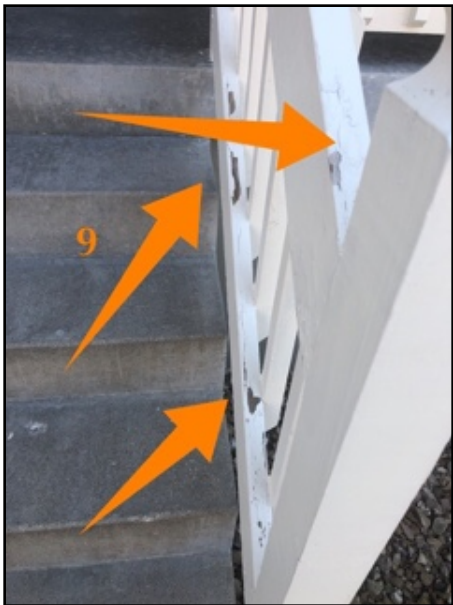
1. Inspector noted missing railing along with rotted stair treads going to the patio. Inspector would recommend replacing these stair treads and installing a railing. Inspector notes termite damage to stair treads.

2. Inspector notes termite damage underneath of the deck at the chimney. Inspector recommends treating the home for termites and replacing all rotted and termite affected wood.

3. Inspector notes support post underneath of the deck that are not properly braced, inspector notes that the footers have sunk. Inspector would recommend pouring concrete footers for proper support.

4. Inspector notes that the ledger board at the lower deck platform is starting to pull away from the home, recommend correction.

5. Inspector recommends scraping and repainting loose, blistering paint around windows and trim most notably on the south east corner of the home.

6. Inspector notes some bowing to the siding on both sides of the home. Recommend monitoring these areas for further deterioration. Inspector notes that all siding was firm and showed no wood rot at the time of inspection.

7. Inspector notes the start of wood rot at the seams on the front lap siding. These areas have been sealed but should be monitored for any further deterioration and repair as necessary.

8. Inspector notes rotted siding on the front of the home to the east side of the front porch, recommend replacing.

9. Inspector recommends replacing rotted spindle on the east side of the front porch. Also recommended to scrape all loose paint at front porch and repaint these areas.

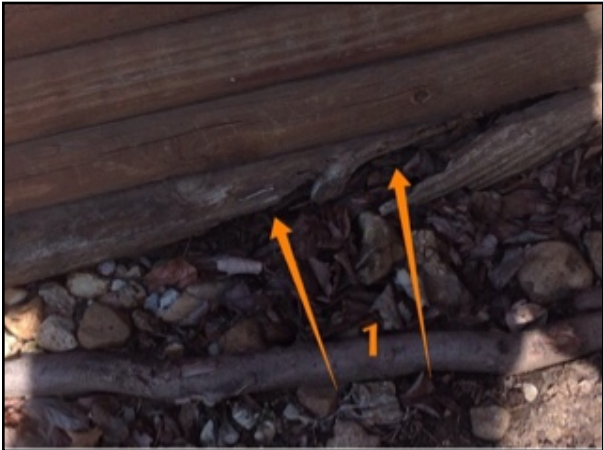
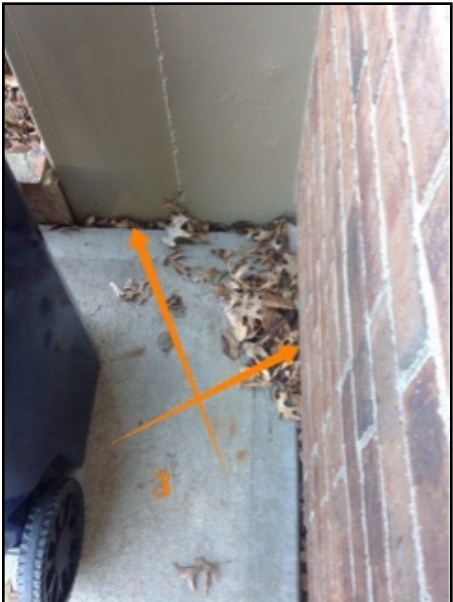
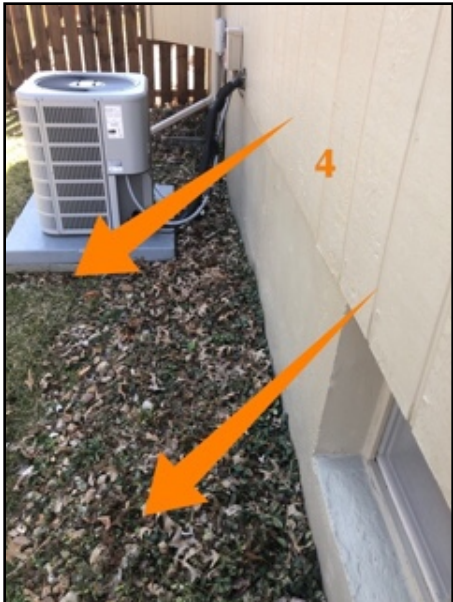
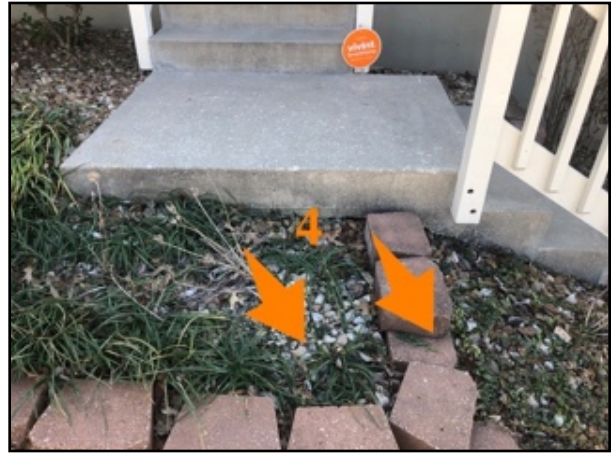
1. Inspector notes termite damage at landscaping timbers on the backside of the home. Inspector recommends termite treatment.
2. Inspector notes that the landscape timbers on the backside of the home have shifted pushing water towards the foundation, Inspector would recommend readjusting the slope for water runoff.
3. Inspector recommends correcting the grading on the east side foundation and under the deck for proper water runoff.
4. Inspector recommends adding rock to build up the rock beds around the front porch and walkway to keep water from getting underneath of these areas.

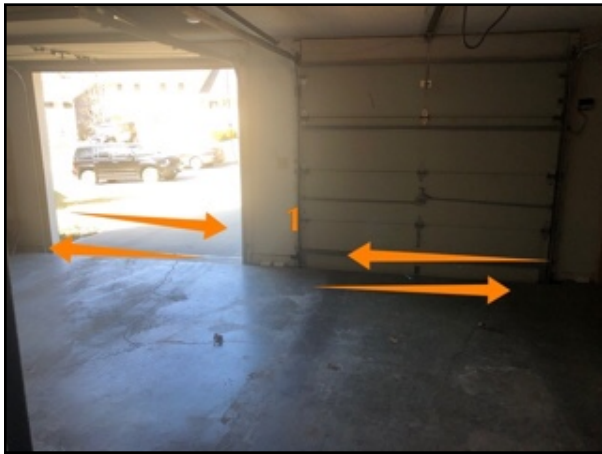
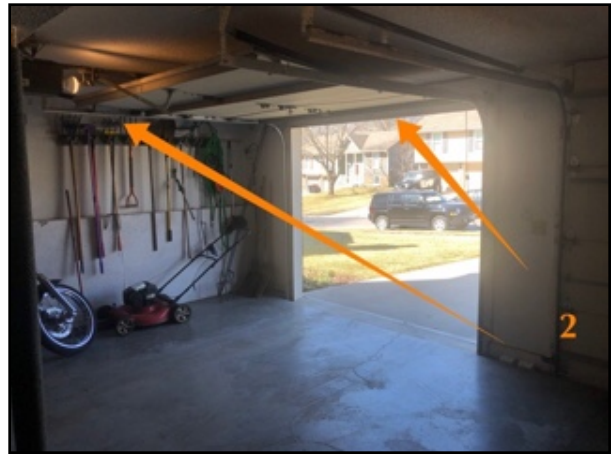
1. Inspector notes that there are not light beams properly fixed at the base of either garage door.
2. Inspector notes that the Westside garage door was very loose and would not shut properly on its own. Recommend repair or replace.

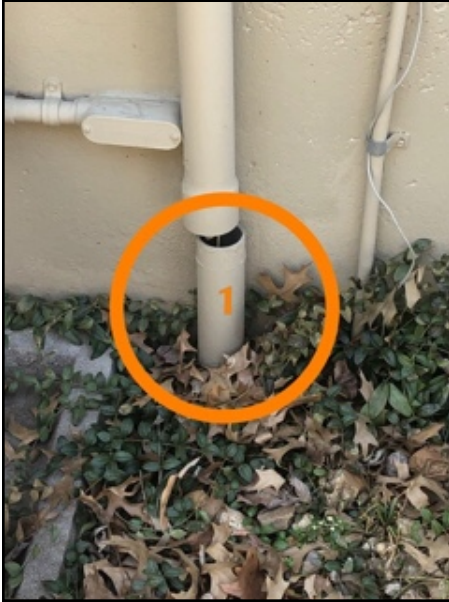
Figure 10-1

Comment 10:
1. Inspector recommends repairing gap in conduit at service entrance.
 2. Inspector recommends installing smoke detectors in each bedroom.

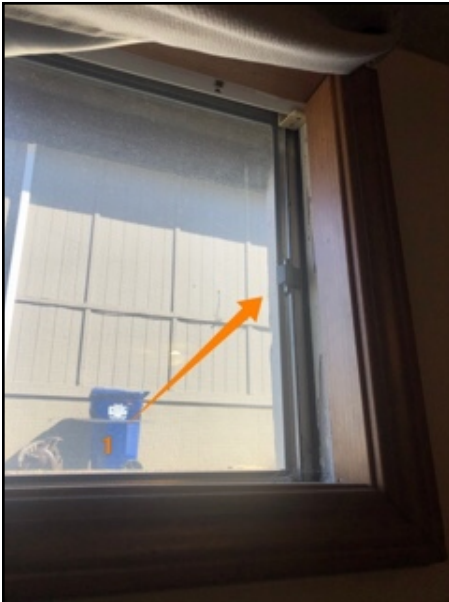
Figure 15-1

1. Inspector notes the basement window will not lock, recommend repair.
2. Inspector recommends repairing closet door next to bathroom door to open and close properly. Inspector would also recommend adding doorstops to all basement doors.

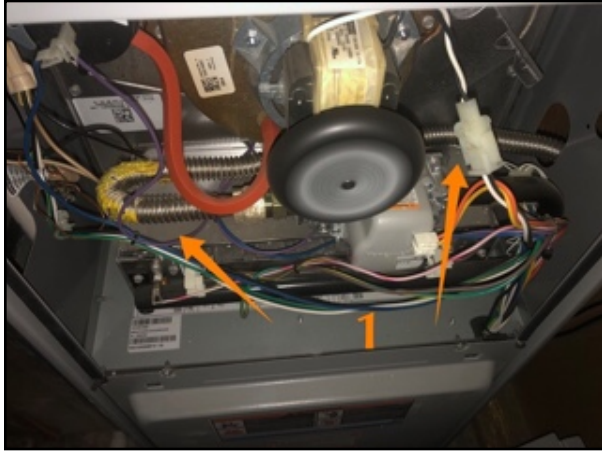
Figure 18-1

1. Inspector notes a flex gas line running into the furnace. Inspector would recommend installing steel gas pipe from the gas valve to the exterior of the furnace and then reconnecting the flex gas line.

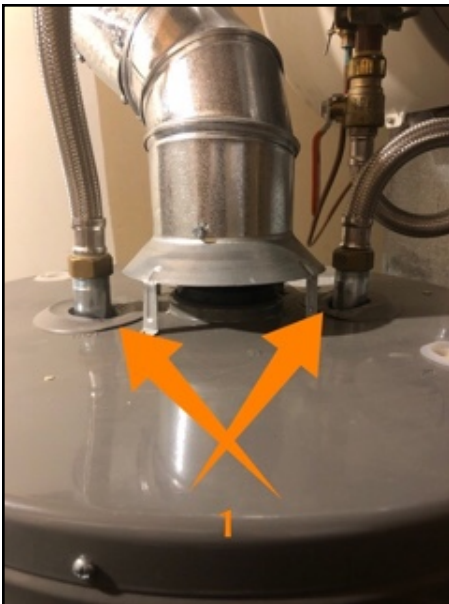
Figure 25-1

1. Inspector notes signs of carbon monoxide backdrafting at the seals around the hot and cold water stems. Inspector conducted a backflow test and carbon monoxide showed to be venting properly. Inspector recommends installing a carbon monoxide detector in the utility closet by the hot water tank.

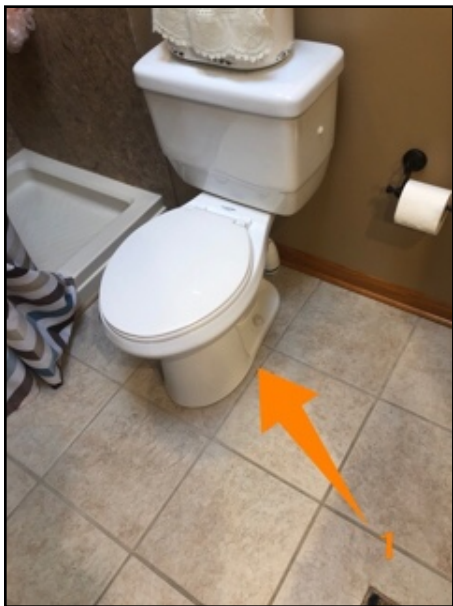
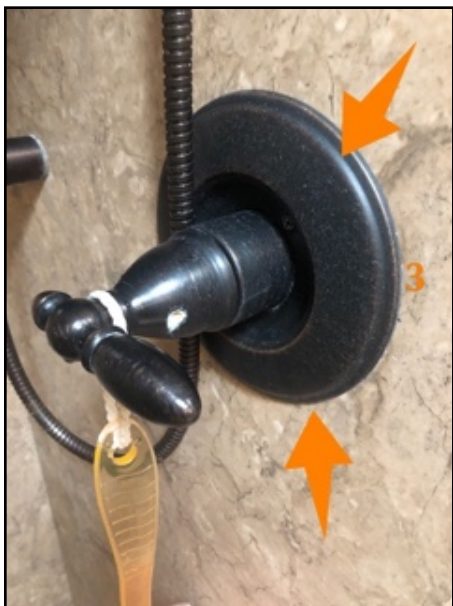
**Comment 28:**
1. Inspector recommends securing toilet to the floor.
 2. Inspector notes that the hot and cold water lines to the shower faucet are reversed.
 3. Inspector recommends securing shower faucet to the wall.

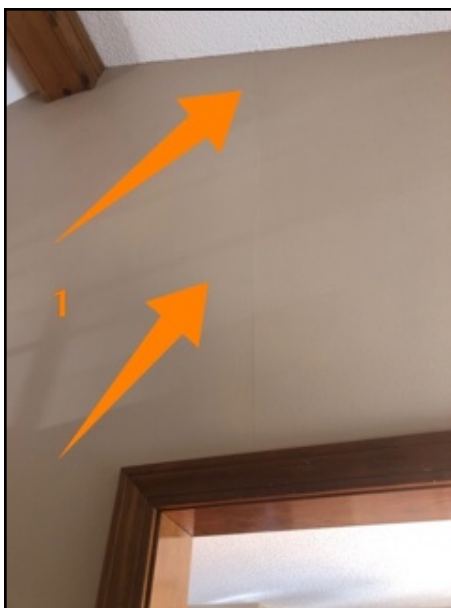
Figure 32-1

1. Inspector notes patched settling cracks above entry to kitchen on the east side of the living room recommend monitoring.

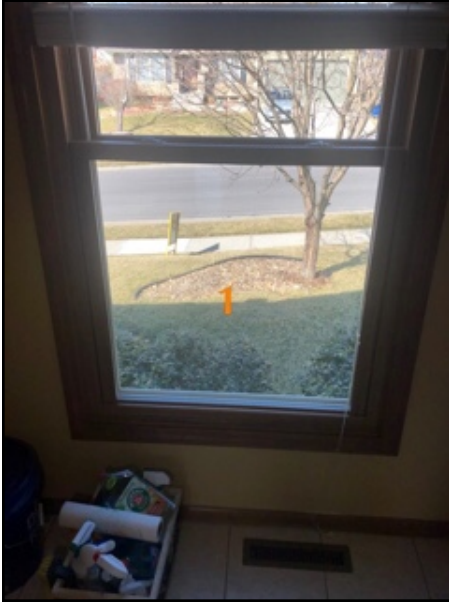
Figure 37-1

1. Inspector notes the bottom sash to the laundry room window would not stay open. Inspector would recommend repairing this window to operate properly.

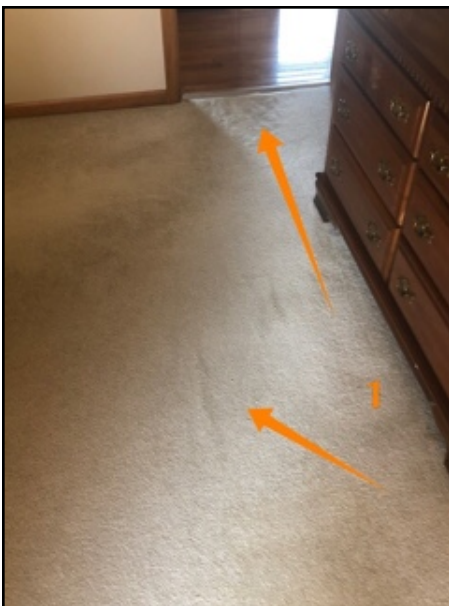
Figure 41-1

Comment 41:
1. Inspector notes bunching Carpet, recommend stretching.

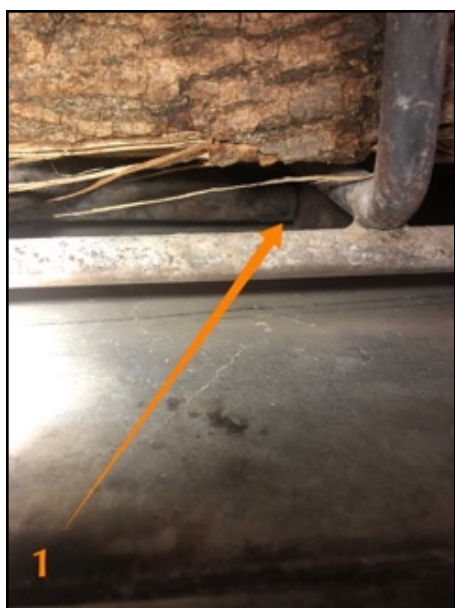
Figure 44-1

1. Inspector notes the gas line has deteriorated and separated in the fireplace, recommend capping or replacing the diffuser.
