## Two Day (48 hour) Radon Test Results

Street Address: 1234 Sample Rd  
 City,State, Zip: Fairfax, VA 22032  
 Structure Type: Walk Out Basement  
 Monitor Location: Finished walkout basement  
 Home Occupied: Yes  
 Weather: Clear, 50's-80's  
 Mitigation System: No

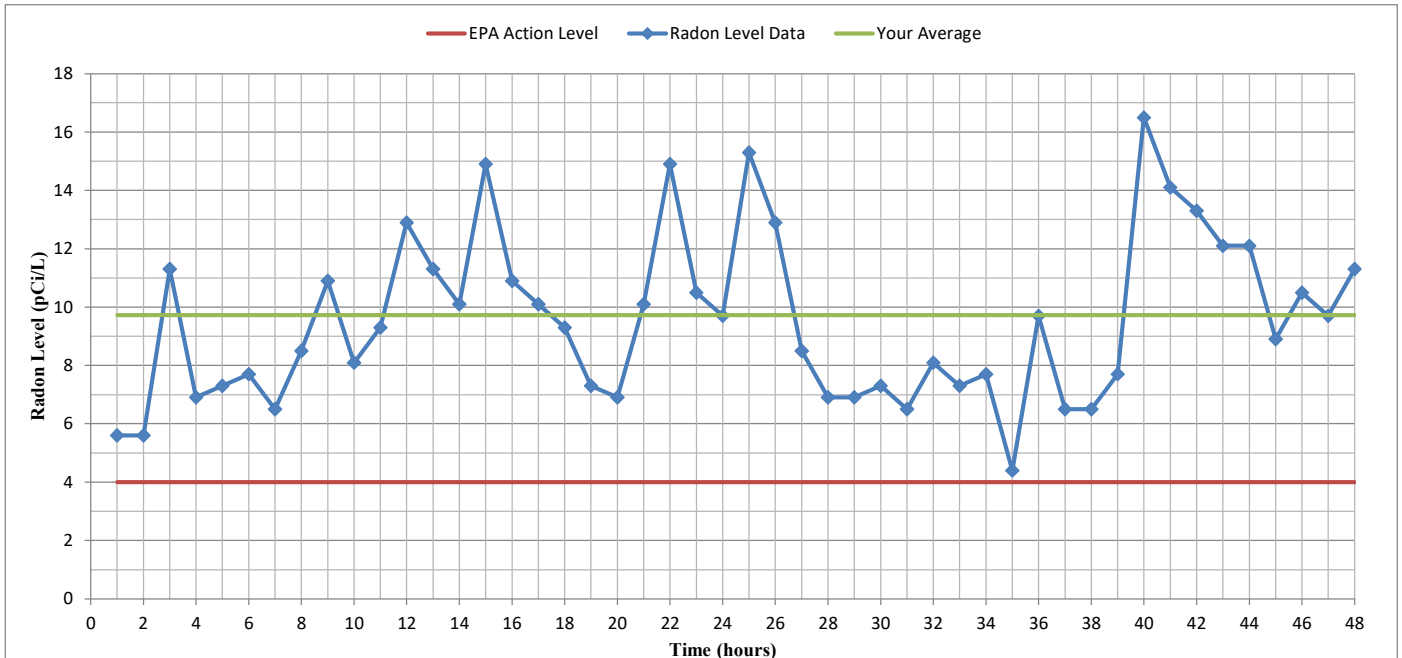
Test Results		
EPA Average:	9.7	pCi/L

EPA Action level is 4.0 pCi/L or higher

NOTES: The first four measurements are discarded from the calculation of the average to allow for equilibration of the CRM equipment (per ANSI/ARST).

Action is needed to reduce the radon levels within the home. Consult a licensed radon mitigation specialist.
