# FlashSeal™

*The Solution for Deteriorated  
Flashings Around Chimneys,  
Stack, and Vents*

# **FlashSeal**

## **Long-Lasting Flashing Repair**

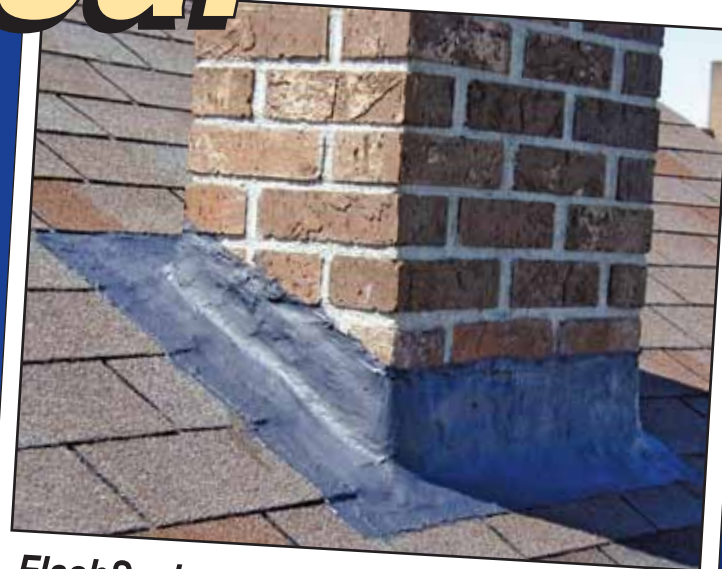
***FlashSeal repairs faulty flashings around chimneys, stacks, and vents***

A properly installed FlashSeal application is like installing a custom fit rubber boot around the base of your chimney. FlashSeal's strength and flexibility will provide years of trouble free service to help stop the damaging effects of water that can enter your home from a faulty or deteriorated flashing system.

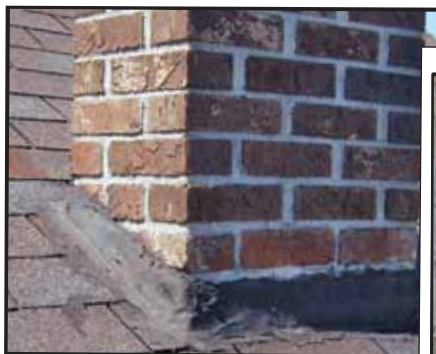
***Chimney with cracked and deteriorated flashing***

Flashing is the material at the base of chimneys, stacks and vents that is designed to waterproof the juncture where they penetrate the roof. Faulty or deteriorated flashings can cause leaks and water damage to the surrounding roof deck or eventually the interior finishes of your home.

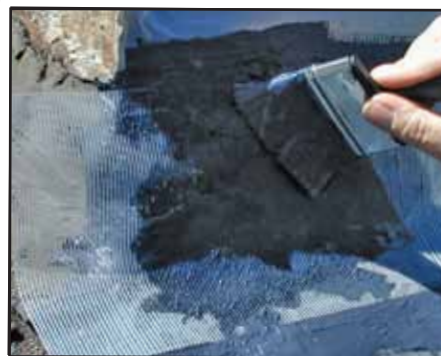
***For added strength and flexibility, a fiberglass fabric is embedded between 2 coats of FlashSeal Elastomeric Sealant***

FlashSeal Elastomeric Sealant is available in one gallon containers and is used in conjunction with FlashSeal Reinforcement Fabric sold separately in 150 ft. rolls. One roll of Reinforcement Fabric will last through 3 - 4 gallons of FlashSeal.

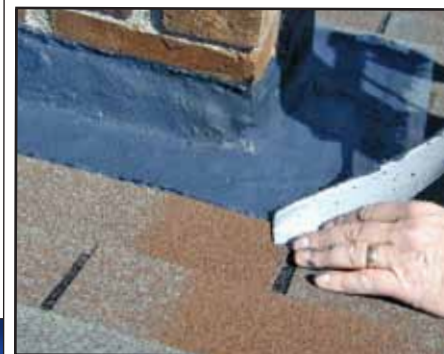
***In most cases the roof deck and chimney are taped off to produce a neat appearance of the finished application***

Simply measure and pre-cut the fabric, the repair is fast, easy, and provides you with a professional flashing repair option that is warranted for seven years! The new FlashSeal repair adds another level of protection to the waterproofing mix. Used with other ChimneySaver products, it will allow you to provide a total system of chimney protection.
