Facts on FURNACE FLUE LINER In Masonry Chimneys

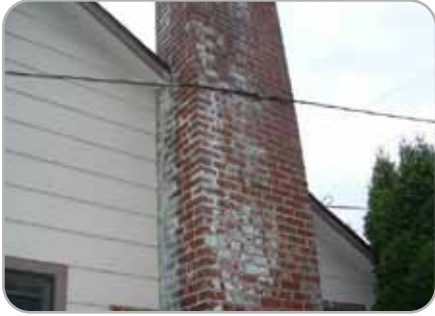
EFFLORESCENCE ON BRICK
Efflorescence is a common symptom of condensation in the chimney, leaving behind white salt deposits.

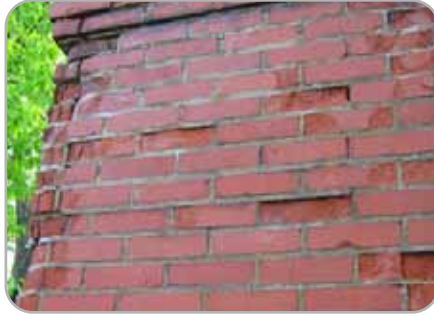
DAMAGED BRICKWORK ABOVE THE ROOFLINE
This is a result of years of condensation on a masonry chimney. Masonry chimneys either need rebuilding or tuckpointing to repair this issue, after a furnace liner is installed.

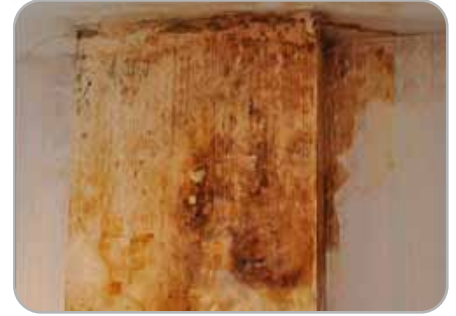
STAINING ON WALLS INSIDE THE HOME NEAR THE CHIMNEY.
If problems with a leaky chimney go unaddressed, it could lead to thousands of dollars of damage to your home.

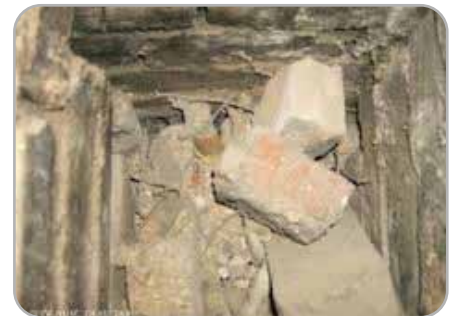
BLOCKAGES IN FLUE
Flue tiles can become damaged due to condensation and block the chimney, causing a carbon monoxide problem in the home.
