# Property Inspection Report

1234 Sample Way, Haymarket, VA 20169  
Inspection prepared for: Chris Sample  
Real Estate Agent: -

Date of Inspection: 4/2/2026 Time: 2:00 PM  
Age of Home: 2004 Size: 2736  
Order ID: 1443

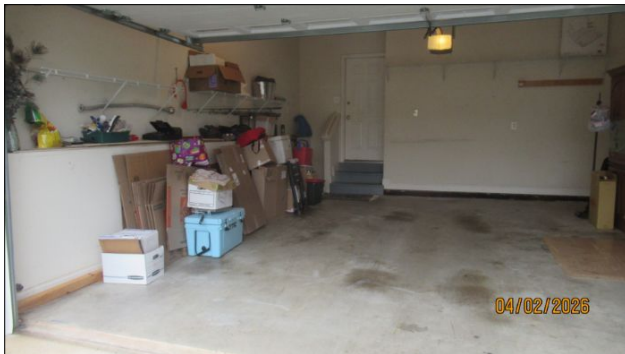
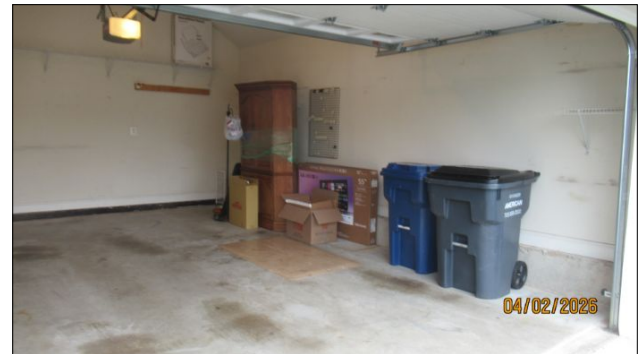
- Due to stored items in the garage, I was unable to determine the condition of a portion of the walls or floors hidden from view. Re-inspect as needed when the room is empty.

limits

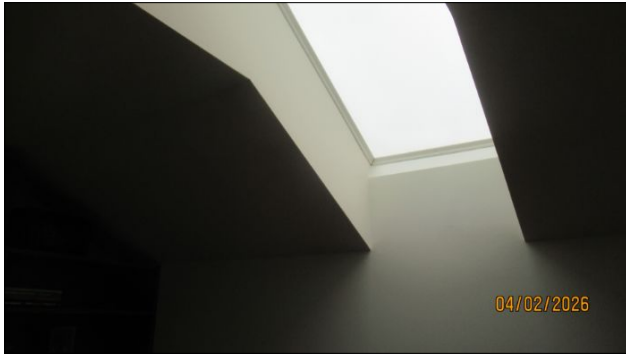
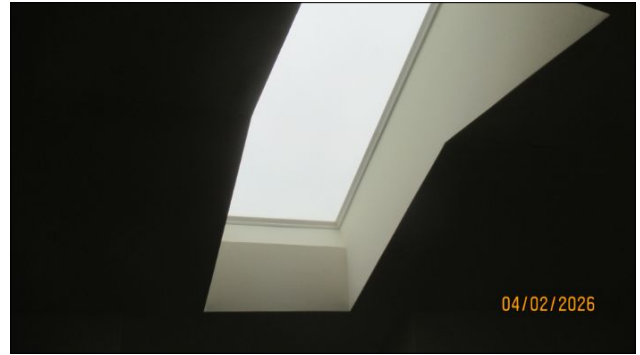
- Skylight components appear in acceptable condition with no apparent signs of leaking.
- Because skylights are a common point of leakage, monitor the condition of the skylight(s) for signs of leakage or change that would signal the need for further evaluation. A licensed contractor or trades person should be consulted at that time for repair or replacement.

satisfactory

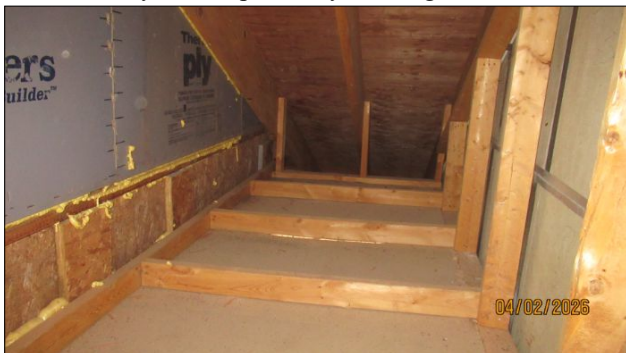
garage attic area

- The attic cavity was inspected by entering the area.

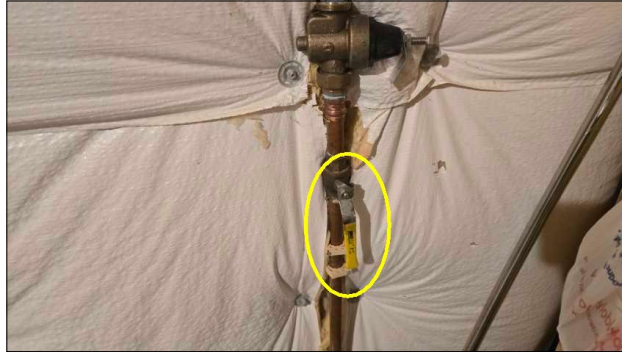
Main water shutoff valve

- Public water source supplied by the city, town or municipality.
- The location of the main water supply shut off is at the foundation wall.
- You should operate the main water valve at least annually to prevent the valve from freezing in the on position preventing emergency shutoff. In addition, it is recommended that you shut the main water valve off anytime you will be away from the home for more than a few days in the event of a leak.

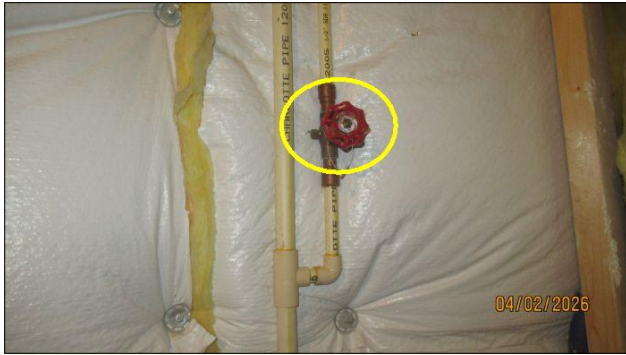
front hose bib shutoff

- The Front exterior hose bib appeared to function normally.
- Rear Hose Bib is Off as tested from the outside. It is wise to have these faucets turned on inside and be able to check them outside at final walk-through. If weather does not permit them being turned on due to freezing temperatures, confirm with sellers they do not leak.

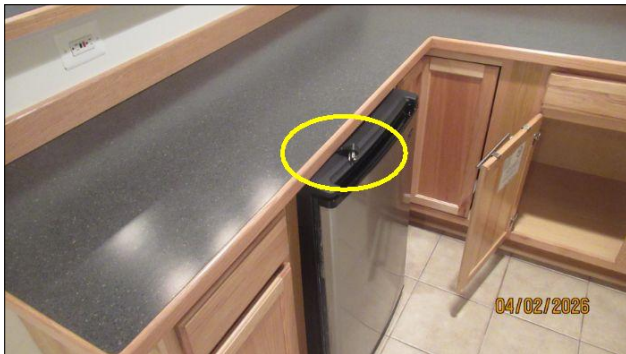
- The bar area refrigerator was not tested as it was unplugged at the inspection. It is unknown if the appliance conveys with the home.
- The sink drain piping slopes toward the front of the cabinet slightly. The sink did drain when tested, however, there were some gurgling sounds when draining indicating some possible venting issues. Repair is advised if this sink is to be used regularly.

refrigerator not plugged in

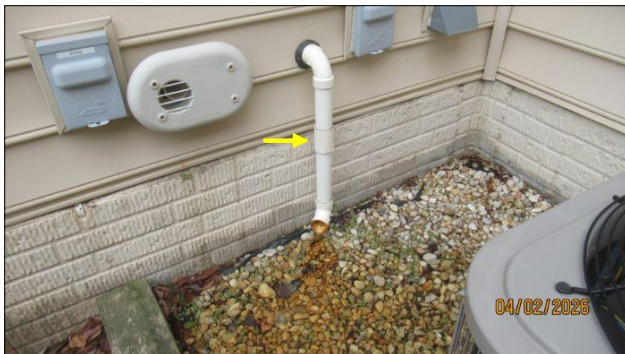
sump discharge

- The sump pump installed is functional. The presence of a sump pump does not indicate there is a need for it. This inspection does not verify the existence of, or effectiveness of, any sub slab or perimeter drainage system.
- There is no battery backup installed. I suggest you consider installing a battery backup system. This may be a positive addition in event of a power failure.

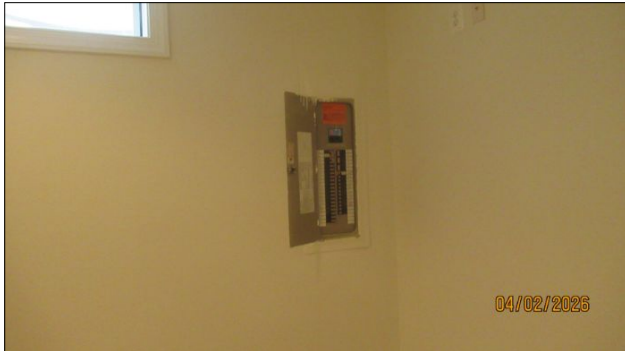
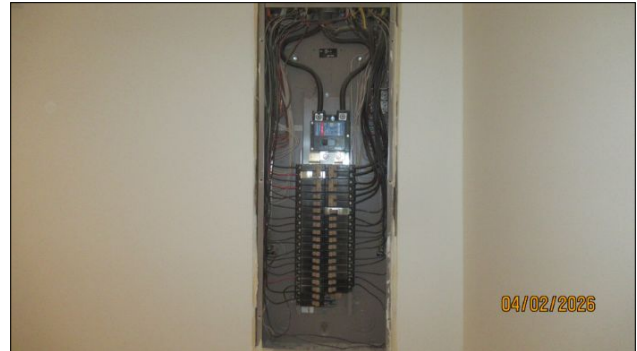
- The main electrical panel is located in the basement
- The dead cover was accessible and removed per inspection standards.

cover removed

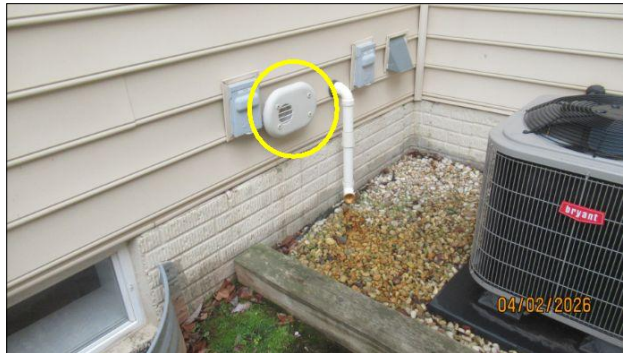
furnace flue exhaust and intake

**Materials:** The visible components are performing as intended. • Induced draft system using an inducer fan to push the burnt exhaust gases out of the flue pipe. • The furnace is a very high efficiency type furnace using an inducer fan to push the burnt exhaust gases out of the plastic flue pipe.

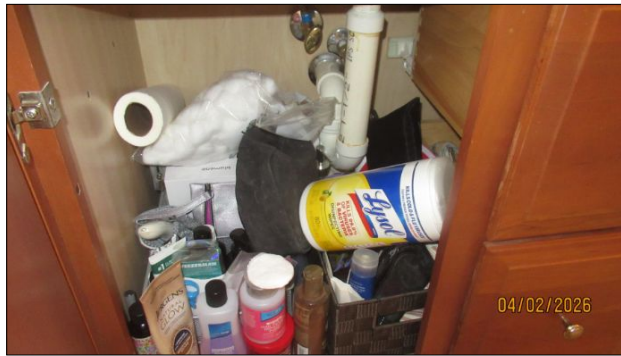
- Bath components were not fully inspected or operated due to restricted view of the inside of the cabinet due to personal effects and storage and is disclaimed. Review this area when emptied and/or at final acceptance of the property for conditions that may require repairs.

limits

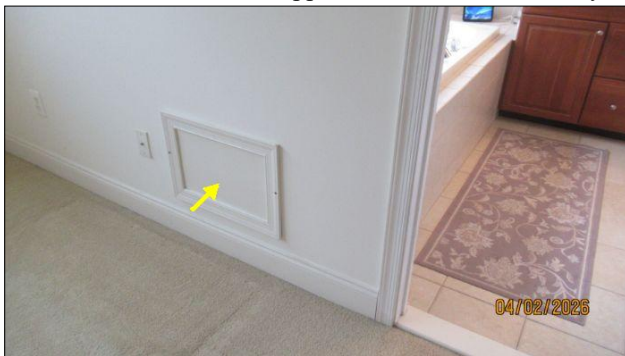
spa motor access

- There is a spa tub installed. The tub was filled with water and the jets activated to observe for proper action. The motor and GFCI is accessible. The tub appeared to function normally.

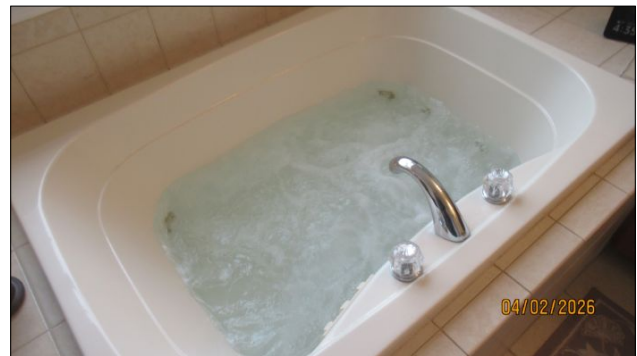
spa tub running
