# Property Inspection Report

12345 First Timers Way, Anytown, VA 20155  
Inspection prepared for: John Q Sample  
Real Estate Agent: Agent Smith - Local Realtor - Mytown

Date of Inspection: 11/4/2017 Time: 0900  
Age of Home: 30 Size: 2200

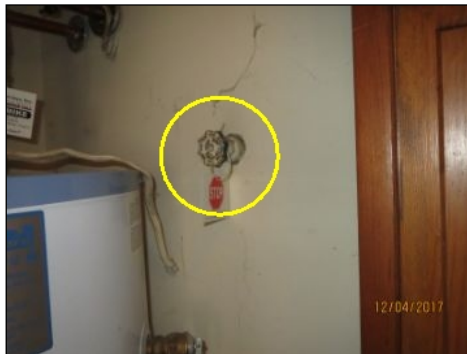
main water shutoff

- Public water source supplied by the city, town or municipality.
- The location of the main water supply shut off is in the water heater room.
- You should operate the main water valve at least annually to prevent the valve from freezing in the on position preventing emergency shutoff. In addition, it is recommended that you shut the main water valve off anytime you will be away from the home for more than a few days in the event of a leak.

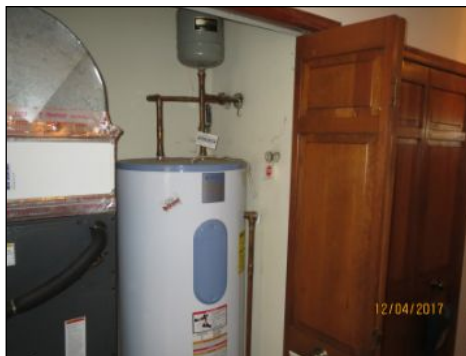
- The water heater is located in a closet.
- Unless otherwise noted within this report, the unit was tested and performed normally. Occasionally, check for proper flueing and general maintenance, i.e. draining the water heater, checking the TPR valve, look for corrosion, leaks etc.

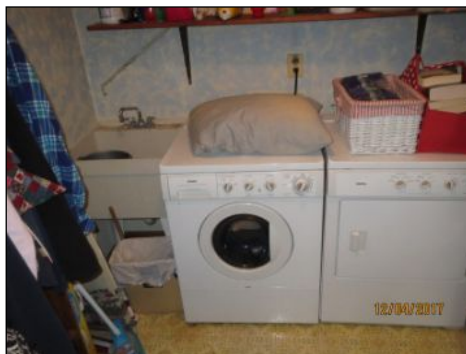
- A washer and dryer are installed. The equipment was not tested due to personal effects are inside the machines and they will not be removed for testing. Some may be listed as-is, or if the client chooses not to, they may not be tested. Check again at your final walk-through.

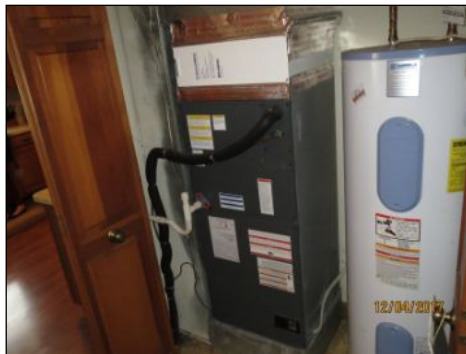
The heating is located Lowest level • The brand of the unit is Goodman

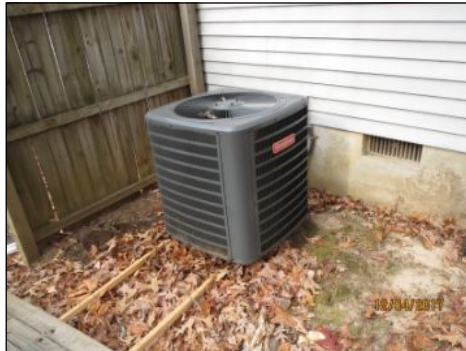
- The unit is approachable, visibly level, clear of obstruction or damage and appears to be satisfactory.

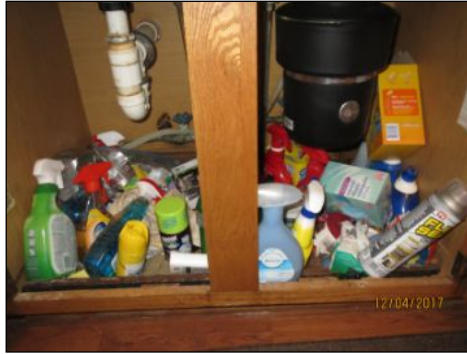
- Kitchen under sink components and other cabinetry, were not fully inspected or operated due to: Viewing below sink area(s) is restricted.

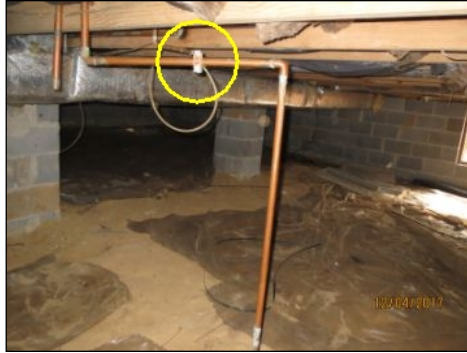
water valve

Observations: The ice and water dispensers worked properly when tested. • There is a water line installed for the refrigerator with a shutoff valve in a remote area. Be sure you are aware of the shutoff valve's location in case of an emergency.
