Diamond Heritage Inspections, LLC.

Home Inspection Report

123 DHI st

Inspected on Sat, Mar 13 2021 at 6:45 AM

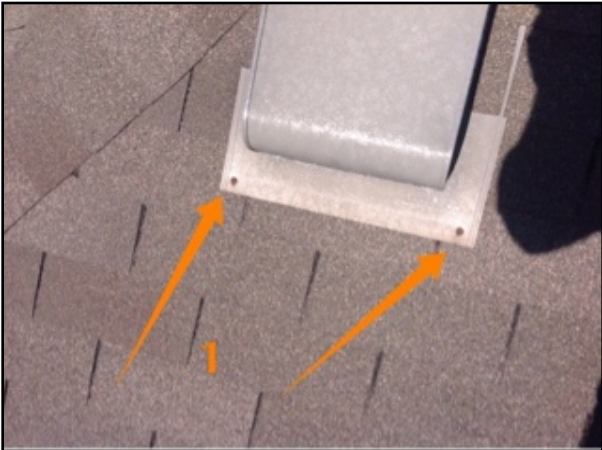
Figure 3-2

- 1) Comment 3: 1. Inspector recommends to seal nails at ridge cap, roof vents, skylights and plumbing vents.
2. Inspector recommends to re-seal rain cap at chimney.
3. Inspector notes rotted siding and trim boards around chimney, recommend replacing these areas.
4. Recommend to add downspout extensions to all downspouts that are not part of the drainage system.
5. Inspector notes deterioration to the ceiling at the front porch. This shows potential water backing up in the gutters. Inspector would recommend correcting the guttering and repairing the ceiling.
6. Inspector notes rotted fascia board at the north west corner, recommend repair or replace.

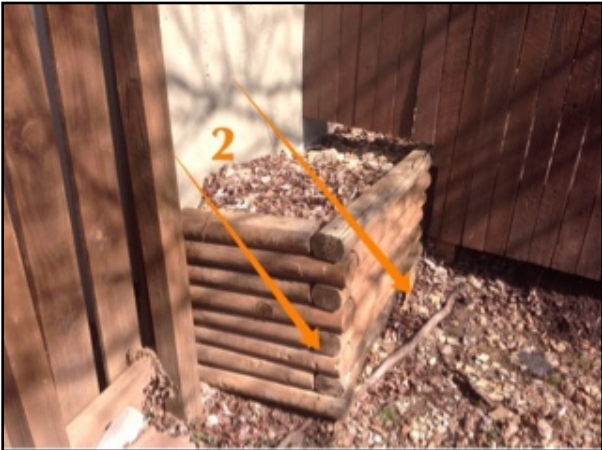
Figure 6-2

3) Comment 6: 1. Inspector notes termite damage at landscaping timbers on the backside of the home. Inspector recommends termite treatment.

2. Inspector notes that the landscape timbers on the backside of the home have shifted pushing water towards the foundation, Inspector would recommend readjusting the slope for water runoff.

3. Inspector recommends correcting the grading on the east side foundation and under the deck for proper water runoff.

4. Inspector recommends adding rock to build up the rock beds around the front porch and walkway to keep water from getting underneath of these areas.

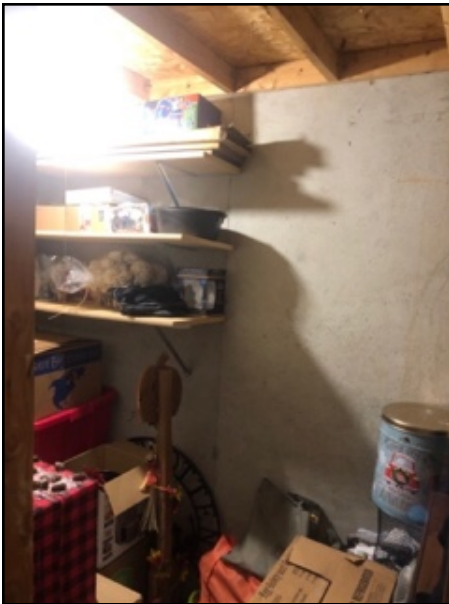
Figure 12-1

Inspector notes very minimal amount of interior structural components can be observed due to finished sheet rock. Structural evaluation is based upon what can be seen at time inspection.

If there are any structural questions regarding the foundation or support of the home, inspector recommends the buyer consult with a licensed and certified Structural Engineer.

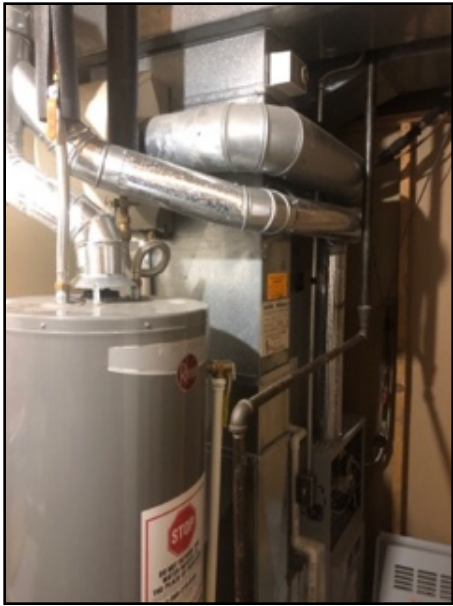
Figure 17-4

1. Inspector notes a flex gas line running into the furnace. Inspector would recommend installing steel gas pipe from the gas valve to the exterior of the furnace and then reconnecting the flex gas line.

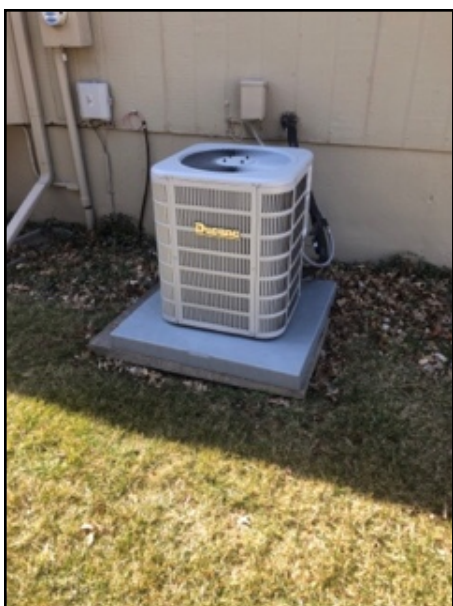
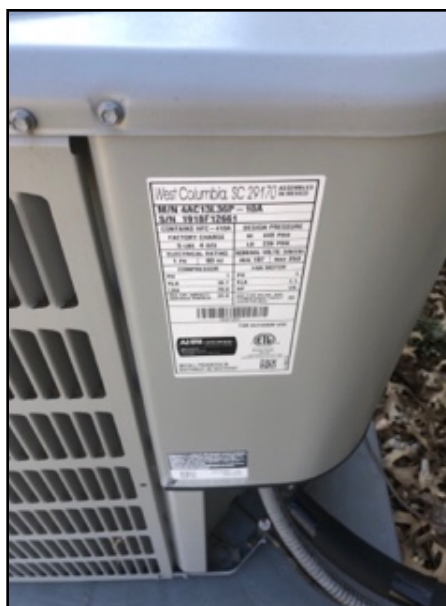
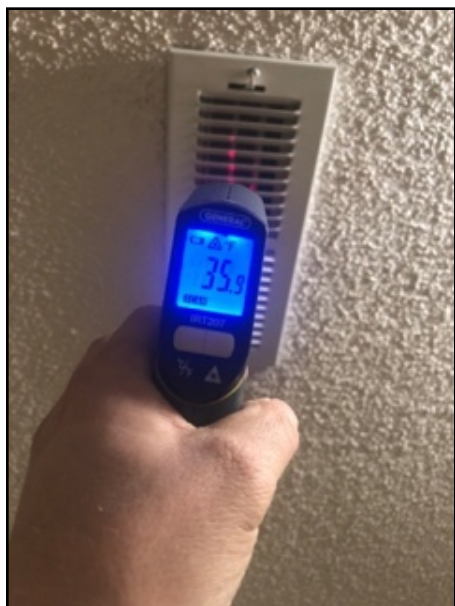
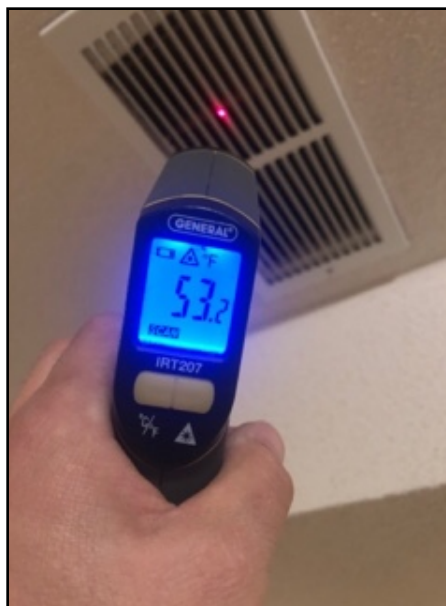
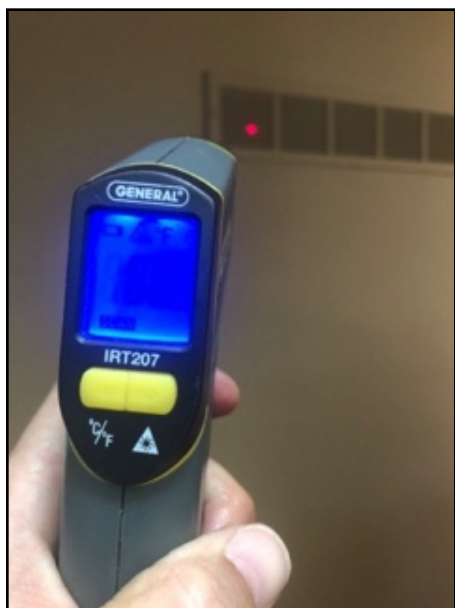
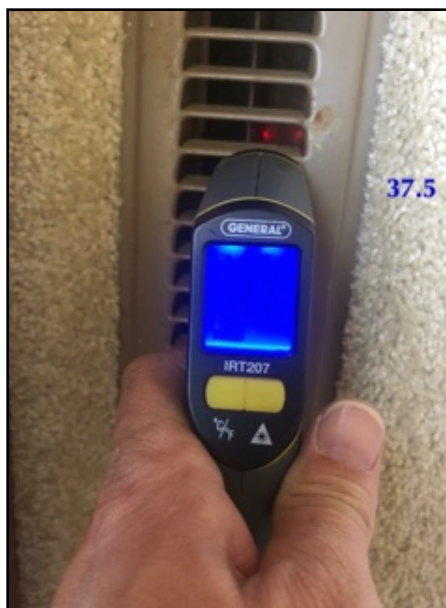
Inspector conducted a T minus test to see the differential between the air supply and air return systems. If the air conditioner is marked as satisfactory then the results of this test were -15° or better. Please see pictures for actual differential.

Air conditioners over 10 years old and heat pumps over 5 years old should be checked, cleaned and serviced yearly by a licensed contractor.

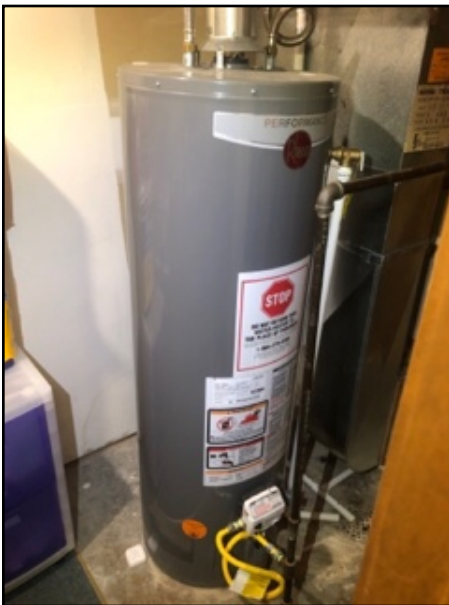
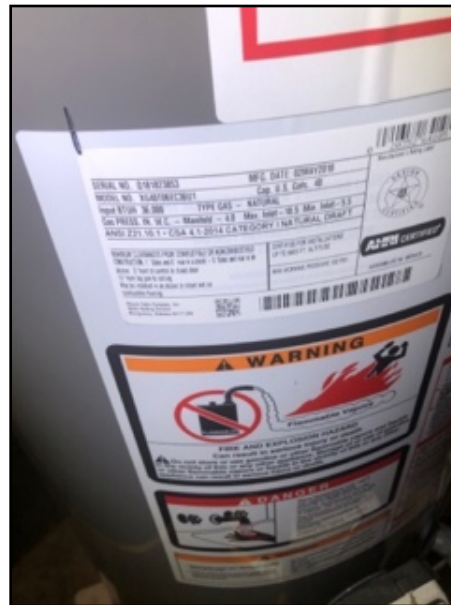
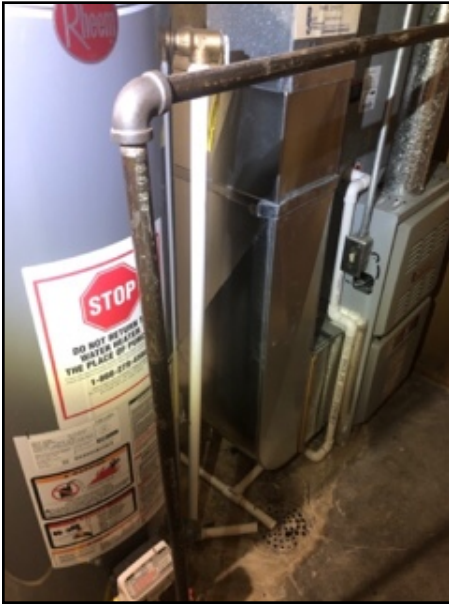
1. Inspector notes signs of carbon monoxide backdrafting at the seals around the hot and cold water stems. Inspector conducted a backflow test and carbon monoxide showed to be venting properly. Inspector recommends installing a carbon monoxide detector in the utility closet by the hot water tank.

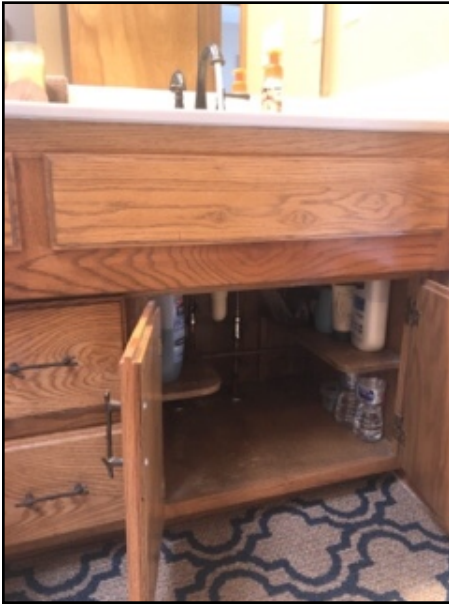
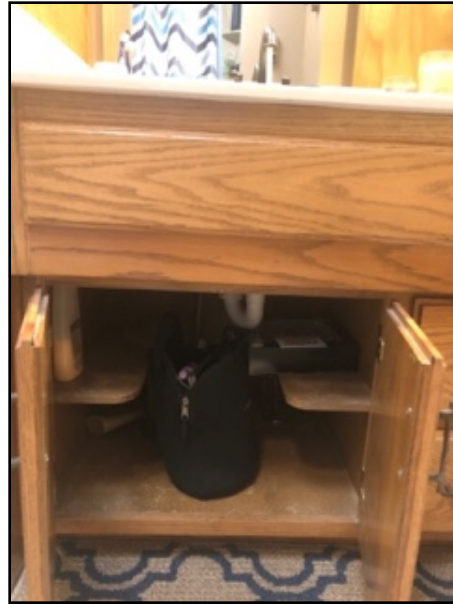
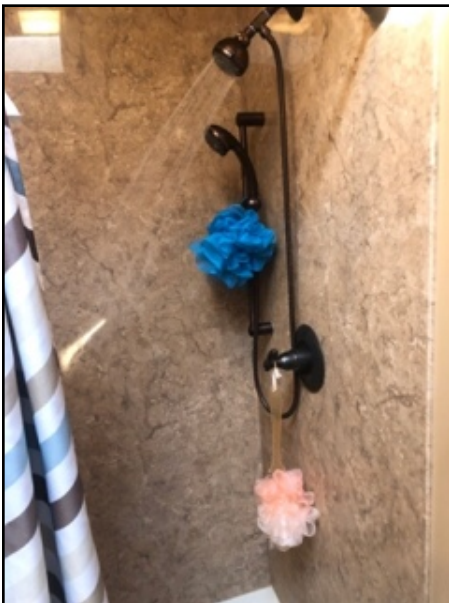
Location:	Primary Bathroom
Bath Tub:	Not Present
Shower:	Stall
	Condition: Repair or Replace
Sink(s):	Double Vanity
	Condition: Satisfactory
Toilet:	Standard Tank
	Condition: Repair or Replace
Shower Walls:	Onyx
	Condition: Satisfactory
Floor:	Tile
	Condition: Satisfactory
Ventilation Type:	Ventilator
	Condition: Satisfactory
GFCI Protection:	Outlets
	Condition: Satisfactory

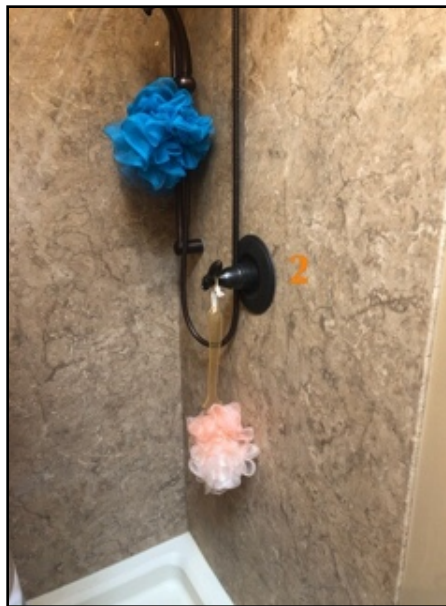
Figure 28-2

**Comment 28:**
1. Inspector recommends securing toilet to the floor.
 2. Inspector notes that the hot and cold water lines to the shower faucet are reversed.
 3. Inspector recommends securing shower faucet to the wall.

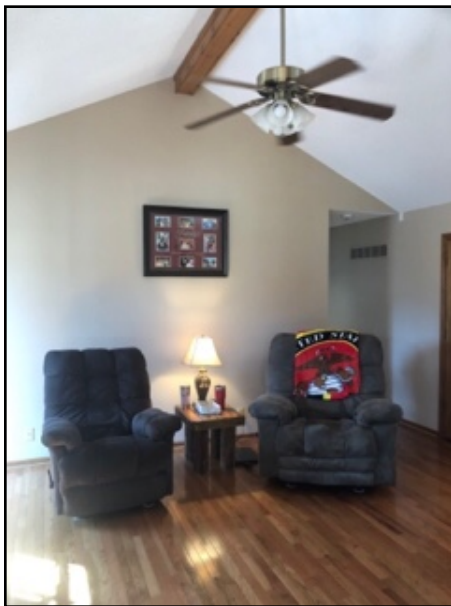
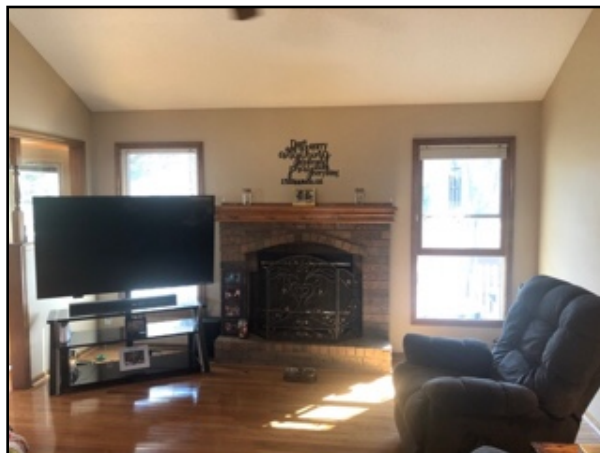
1. Inspector notes patched settling cracks above entry to kitchen on the east side of the living room recommend monitoring.
